A Cautionary Tale: Incorrect Factory Installation of a Main Gear Down Limit Switch in a Twin Comanche

by David Clark, A&P, ICS #08592

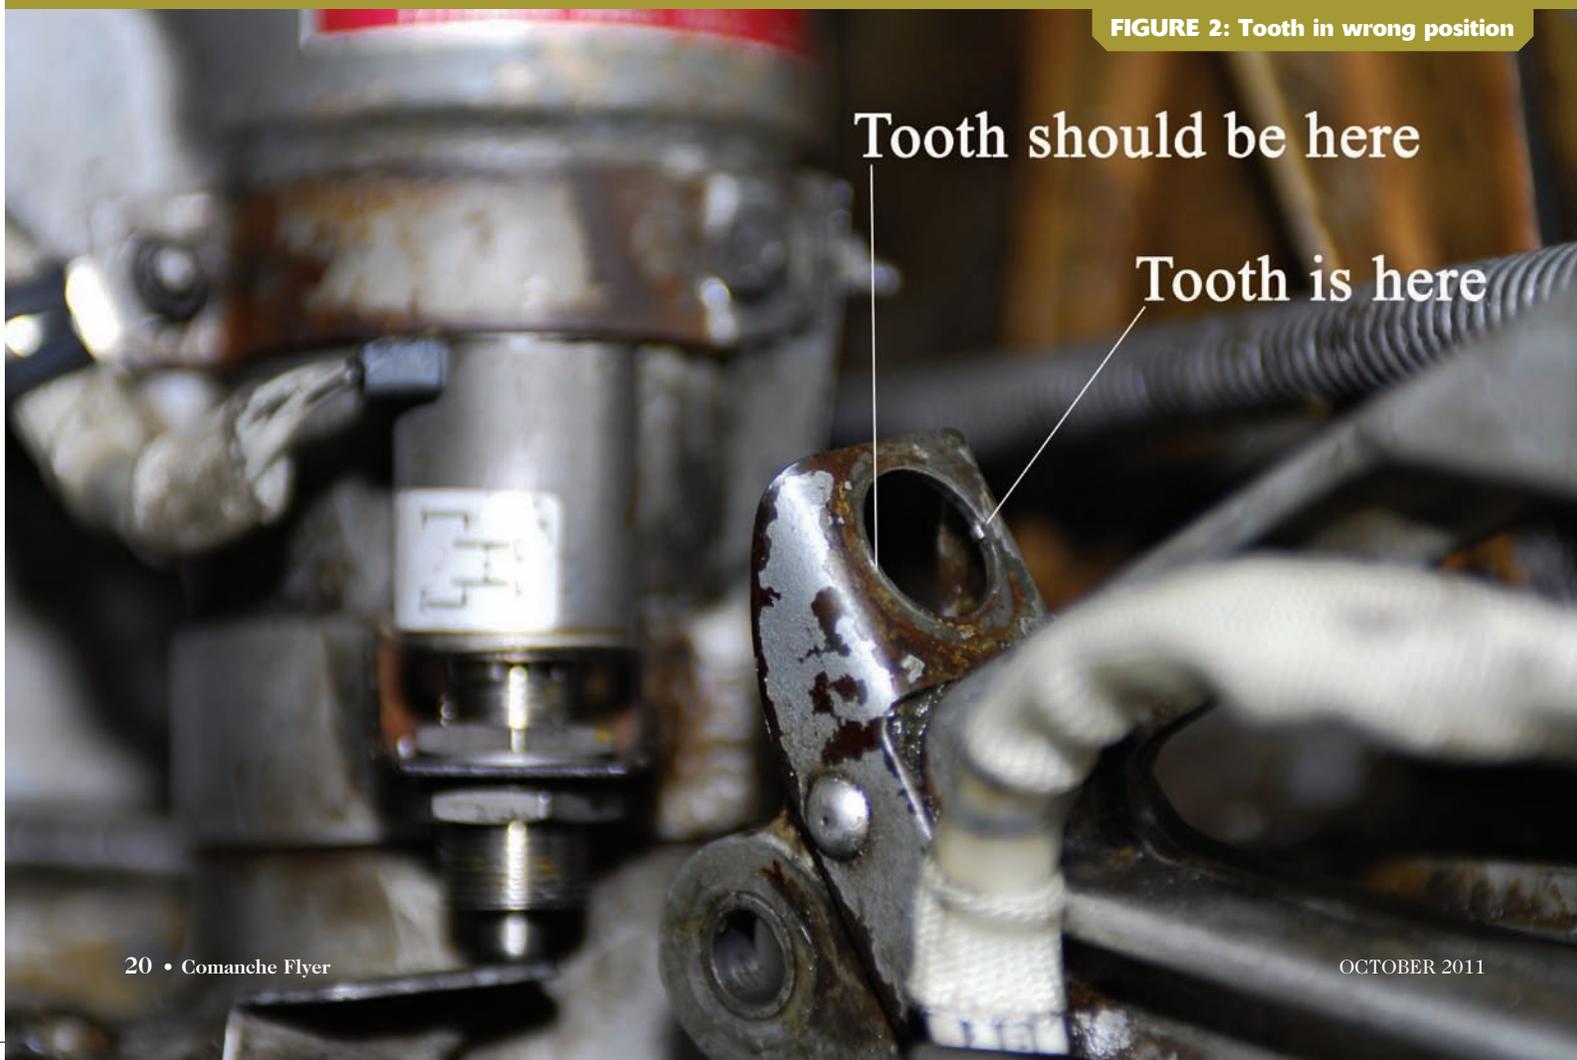
FIGURE 2: Tooth in wrong position

Let me back up and explain. The large triangular part that is the upper drag link is, with one minor exception, identical on both the right and left landing gear on Comanches. There is a stamped metal bracket riveted to the drag link that holds the down limit switch. The brackets themselves are very slightly different in that they have a small tooth or tine in the switch-mounting hole which interfaces with a small slot or keyway in the threaded portion of the switch, and thus orients it correctly with regard to the wiring that emerges from the top of the switch. Both right and left brackets, once mounted on the drag link, have that tooth at the back of the hole or toward the tail of the plane. This feature alone determines whether you have a right or left upper drag link (see Figure 2).

4. Simply file down the tooth on the bracket. Then orient the switch and wiring correctly, and tighten it down with a star washer and nut. This last solution did not require removing the drag link from the plane.

I opted for choice number four. I ended up calling Matt Kurke to get a second opinion on this problem. He told me that he had also seen this situation, and he agreed with me that there was essentially no downside for choosing that solution. He said that it was what he would have done.

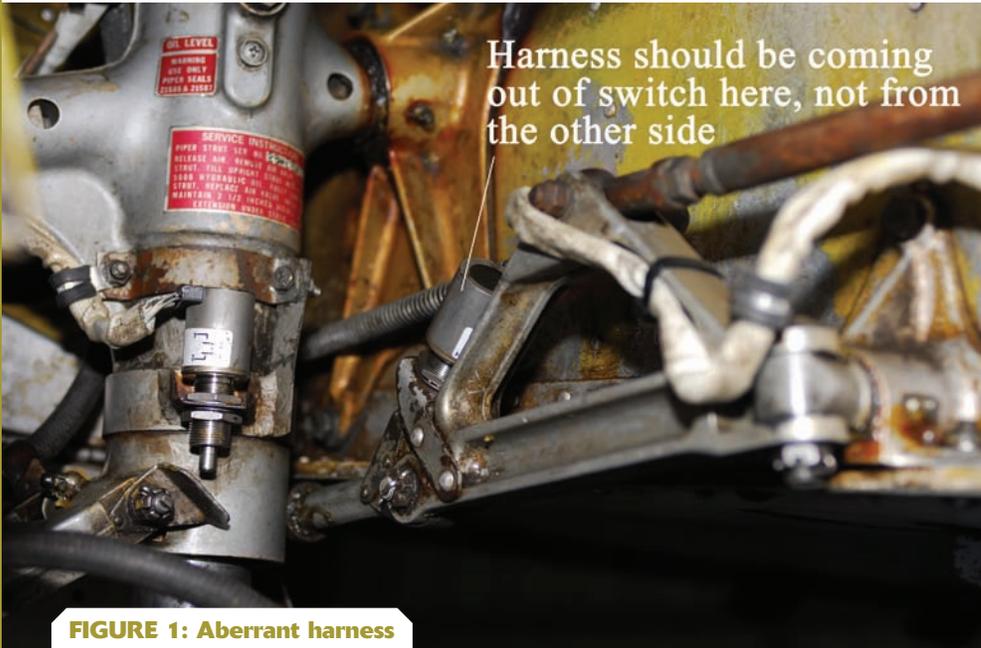
Harness should be coming out of switch here, not from the other side

FIGURE 1: Aberrant harness

The assist spring is the coiled spring that on one end attaches to a standoff bracket at the top of the drag link. On the other end, the spring attaches to a bracket arm that is mounted on the inboard side of the strut housing. The proximity of this spring to the down limit switch requires one to orient the cable in an aft direction to avoid contact between these two components (see Figure 1).

Although the silicone sleeve that surrounds the wiring harness was still intact, I could see where the spring had been rubbing against it. Obviously, this is not a desirable situation. I took the bolt out of the upper drag link connection to the bearing rod end and then removed the bolt that goes through the side brace stud. In no time the switch was removed from the bracket on the drag link. My suspicions were confirmed. This aircraft had two RIGHT upper drag links.

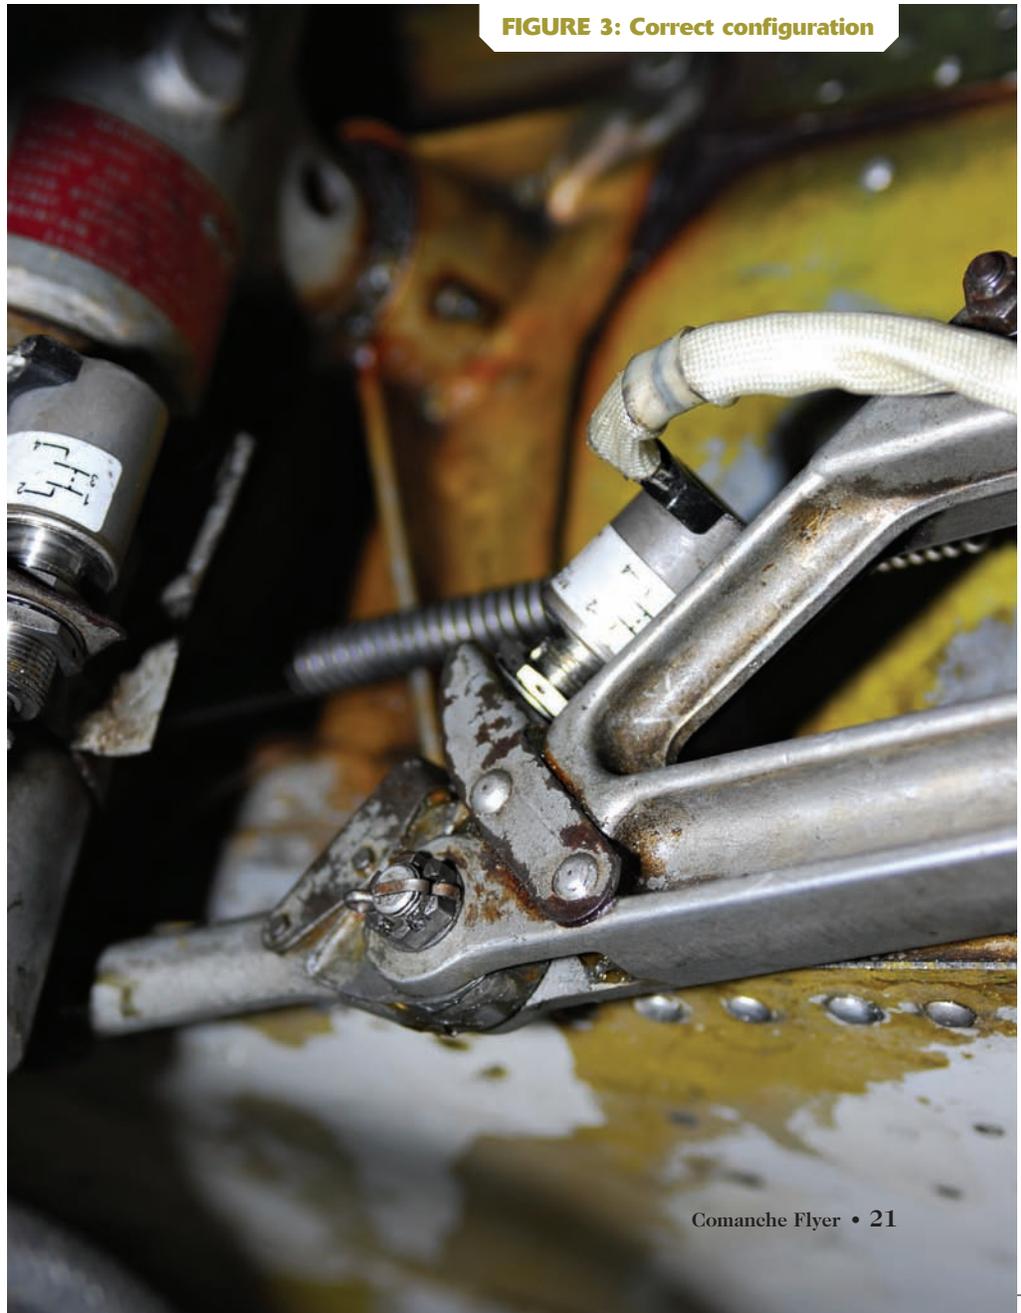
FIGURE 3: Correct configuration

If, on the assembly line at Piper, an assembler were to pick up an incorrectly tagged right upper drag link while working on a left main gear, he might not notice it unless he made a very close inspection. If he then mounted this wrong part on the landing gear, it would lead him to install the down limit switch aberrantly as well. I suspect the orientation of the tooth in the bracket was placed there for just that purpose, i.e., to assure the harness was oriented properly and thus kept out of harm's way in rubbing against the assist spring. Thus, if the assembler didn't notice the first mistake, it virtually guaranteed that he would make the second mistake because the "idiot-proof" bracket will permit the switch to be installed only in one direction (see Figure 3).
