Tips from Comanche *Flyer* magazines Feb 1973 – Sep 2012

CHAPTER FOUR

ELECTRICAL SYSTEM (BATTERY ISSUES, CABLING, ELECTRONIC CIRCUITRY/WIRING, CONTROLS GENERATOR)

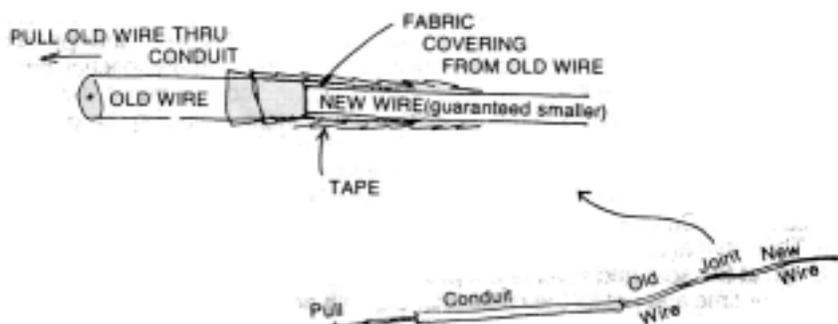
My old wires showed no signs of excessive heat, although I had previously replaced the battery solenoid to starter solenoid cable, which was a real mess, and showed a 3V drop all by itself when starting. Nevertheless, I'm glad I did it, even though it was a long, hard, dirty job – probably a 10 man-hour job at a good shop. Cranking speed has clearly improved, but I haven't made any precise measurements.

Maneuvering the crimper around in a crowded area is impossible, so crimp the lugs on before routing the cable ends to their final destination. Don't forget to put grommets and cable hoods on before the lugs. Also, don't solder the lugs – solder sets up a rigid boundary in the cable which is subject to fracture under vibration – crimping is enough, but you must use the proper tooling.

When all is done, merely put the airplane back together, and complete the log entry. This constitutes a minor repair, so of course has to be written off by an A&P. You may have to update the weight and balance (my fat copper wire added about 3 lbs. to the empty weight).

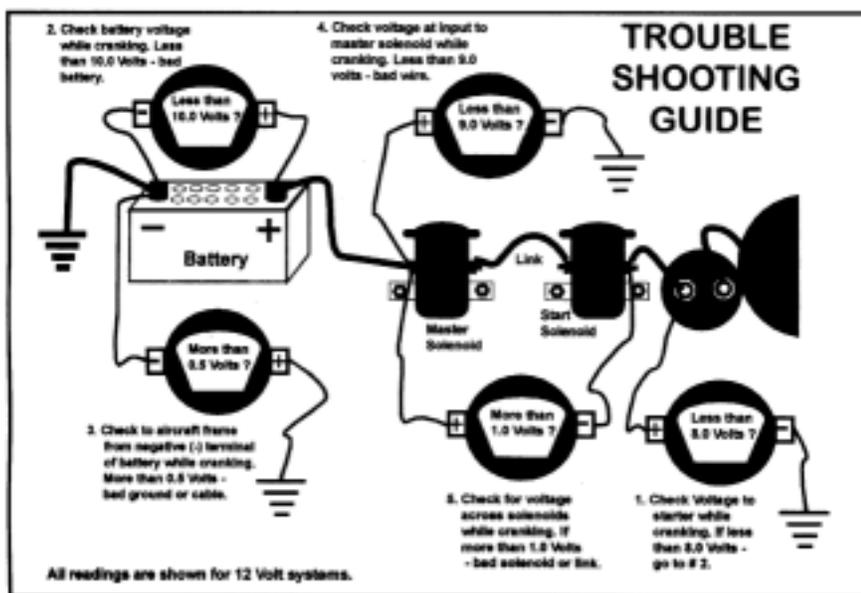
Mr. Graham says, that when swapped into a Tiger, the starter cranked fine. This reveals more about the condition of the aircraft electrical system than the size of the engine. The newer Tiger has a relatively short run of wire between the battery and the starter and it is good #2 copper.

Yes, there are potential problems with the LASAR system. If the system voltage drops below about 9 volts while cranking, the LASAR will disable itself. That is why Unison suggests a method of resetting the LASAR. This drop can, and will, happen with ANY starter, depending on the wiring condition and the charge state of the battery. The Sky-Tec draws about 30% more current than the original equipment Prestolite, so the LASAR problem shows up sooner. It would be a better solution if Unison disabled the low voltage detection during cranking. We do not understand why they have not done so.

In conclusion, there are hundreds of Sky-Tec lightweight starters installed in Comanche 250 and 260 aircraft – cranking them at twice the RPM of the original equipment Prestolite starter and saving 10 pounds. To quote a popular author of the 1960's, "There ain't no such thing as a free lunch." To crank the engine twice as fast, the Sky-Tec starter produces 2 Brake-Horse Power – versus 1.4 for the original-equipment starter. This takes more current. When a higher current starter is installed in an aircraft with known wiring problems, such as the Comanche's original aluminum cable, it may take more than just swapping wire to get the desired performance. Careful voltage measurements made using the free Sky-Tec troubleshooting chart will find and fix the problems every time.
