CHAPTER SEVEN

LANDING GEAR / BRAKES (WHEELS, TIRES, STRUTS, BRAKING MECHANISM)

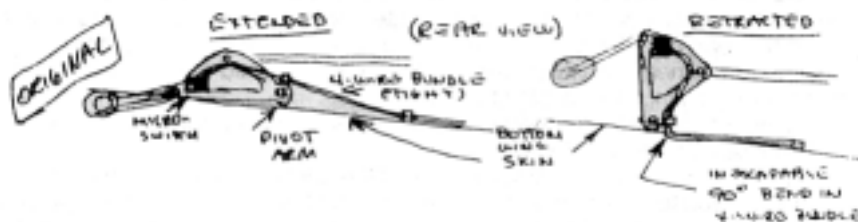
I've wanted to send you a note on the PA-30 landing gear microswitch wiring – we had a broken wire on left main where the 4 wire bundle had to bend due to gear retraction, VIZ.

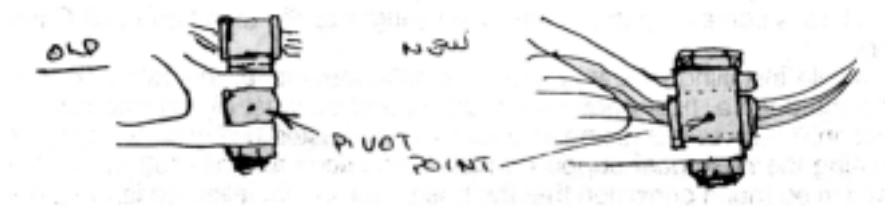
My diagnosis of the basic problem:

The cable clamp at pivot arm if factory positioned – holding cable about 1 1/2" away (radius) from pivot point. The result has to be a large transverse motion of the bundle as the gear retracts. My solution: Reverse the position of the 4 bundle clamp on pivot arm as follows:

This reduces the transverse distance the clamp (ergo-bundle) has to travel to about 1/4" more / less. Basically, the clamp now rotates only instead of rotating and traveling.

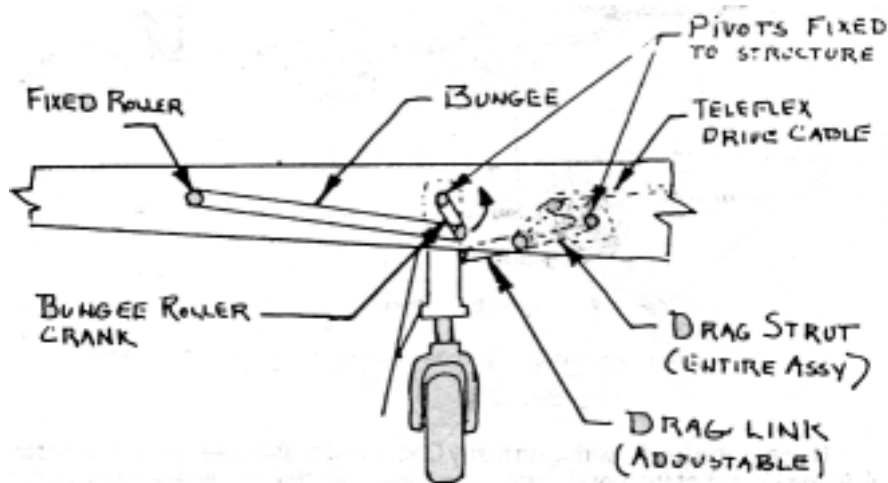
SKETCH "A"
Looking Forward Left Wing
Gear Down -- Bungee Crank Correctly Installed

Notice in sketches "A" and "B" that the bungee tension is increased until it goes over geometric center (approximately 45 point of travel) then it begins to assist the gear in its direction of travel either up or down.

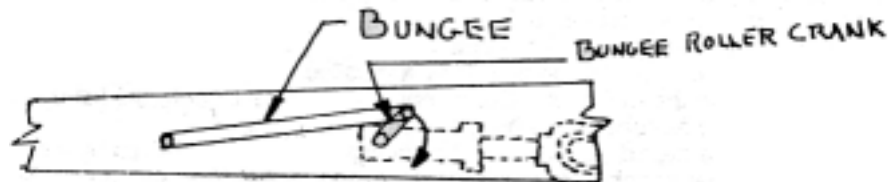
SKETCH "B"
Looking Forward Left Wing
Gear Up -- Bungee Crank Correctly Installed

Sketch "B" shows the bungee roller crank in the correct position when the gear is up with an arrow showing the direction of rotation when the gear is cycled down.

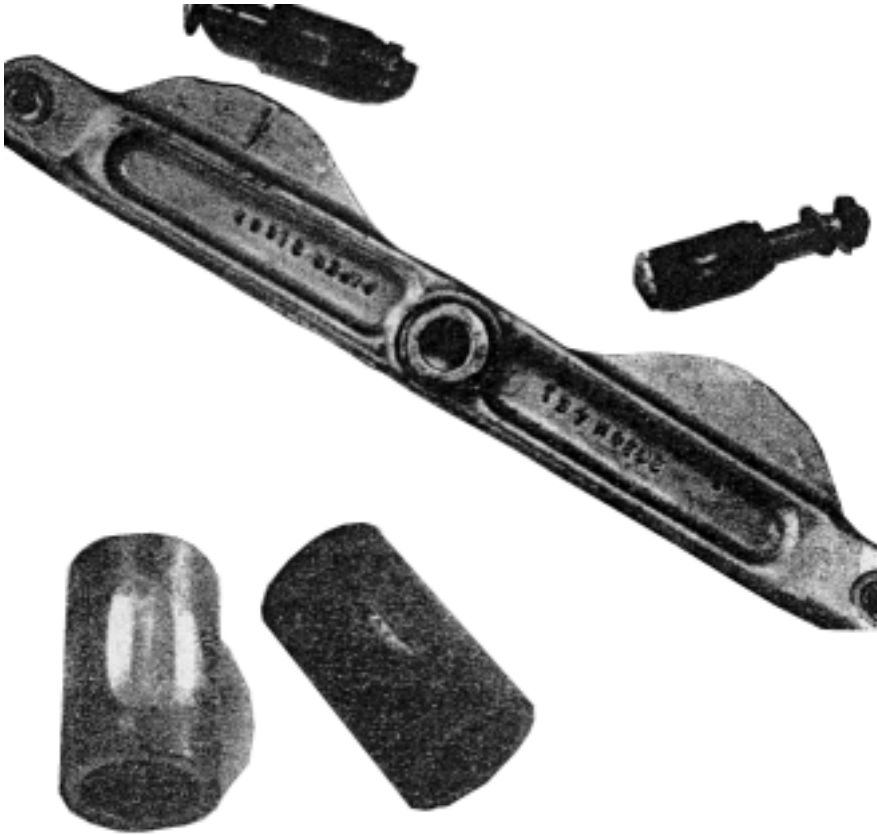
Items overlooked in a series of cheapie annual inspections have a way of snowballing and becoming (ultimately) very expensive. A case in point: When I took my first hard look at my Piper Comanche (a 180 model), I discovered that the nose gear steering bellcrank (Piper P/N 21768-00) showed evidence of peening on its cam faces. If you'll look at the accompanying photographs, you can see the distinct wear points on the cam(s) and on the steering arm bushings (Piper P/N 14976), which were worn to hourglass shapes and showed evidence of not turning. The steering arm bushings function as rollers on the bellcrank's cam faces.

According to the Piper Comanche service manual, these bushings ought to rotate with a slight drag. The book actually calls out several dash numbers of the part, representing several diameters, which can be used to obtain proper adjustment.

It is evident that as wear of the bushings progressed, the excess clearances were enough to allow peening or hammering of the cam faces due to increased play in the nose steering. A couple of my otherwise inexplicable swerves on the runway are readily excused on the basis of this wear. Less explicable is the ongoing lack of inspection and maintenance during the 23 year life span of the all consuming "period piece" that I bought to fly (and maintain!) as a hobby. Thanks to years of oversight and neglect, I had to remove the abused pieces and suffer an inordinate assault on my cash flow for the machinists spent five hours setting up the bellcrank (and five minutes to do the actual cutting) because of the need for the bushing rollers to follow both cam profiles, simultaneously, without binding. Also, I spent a couple hours on a lathe cutting out new oversize bushings from 4130 steel bar stock.

Considering the need for repeated removal and installation of the offending pieces, and the time consumed obtaining a field approval of the repair from the FAA, I felt this whole exercise could have been much less expensive, had a whole series of mechanics more carefully inspected the nose steering parts over the years. How much simpler it would have been had the bushings been routinely inspected and replaced – for the steering bellcrank itself would not have been damaged, necessitating expensive repair or replacement. (I would guess that more than half the Comanches and Twin Comanches still in service have suffered similar wear and neglect.)

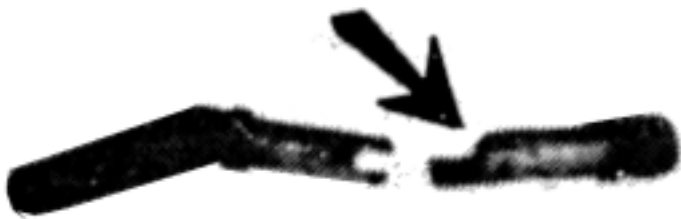
Arrow points to missing piece

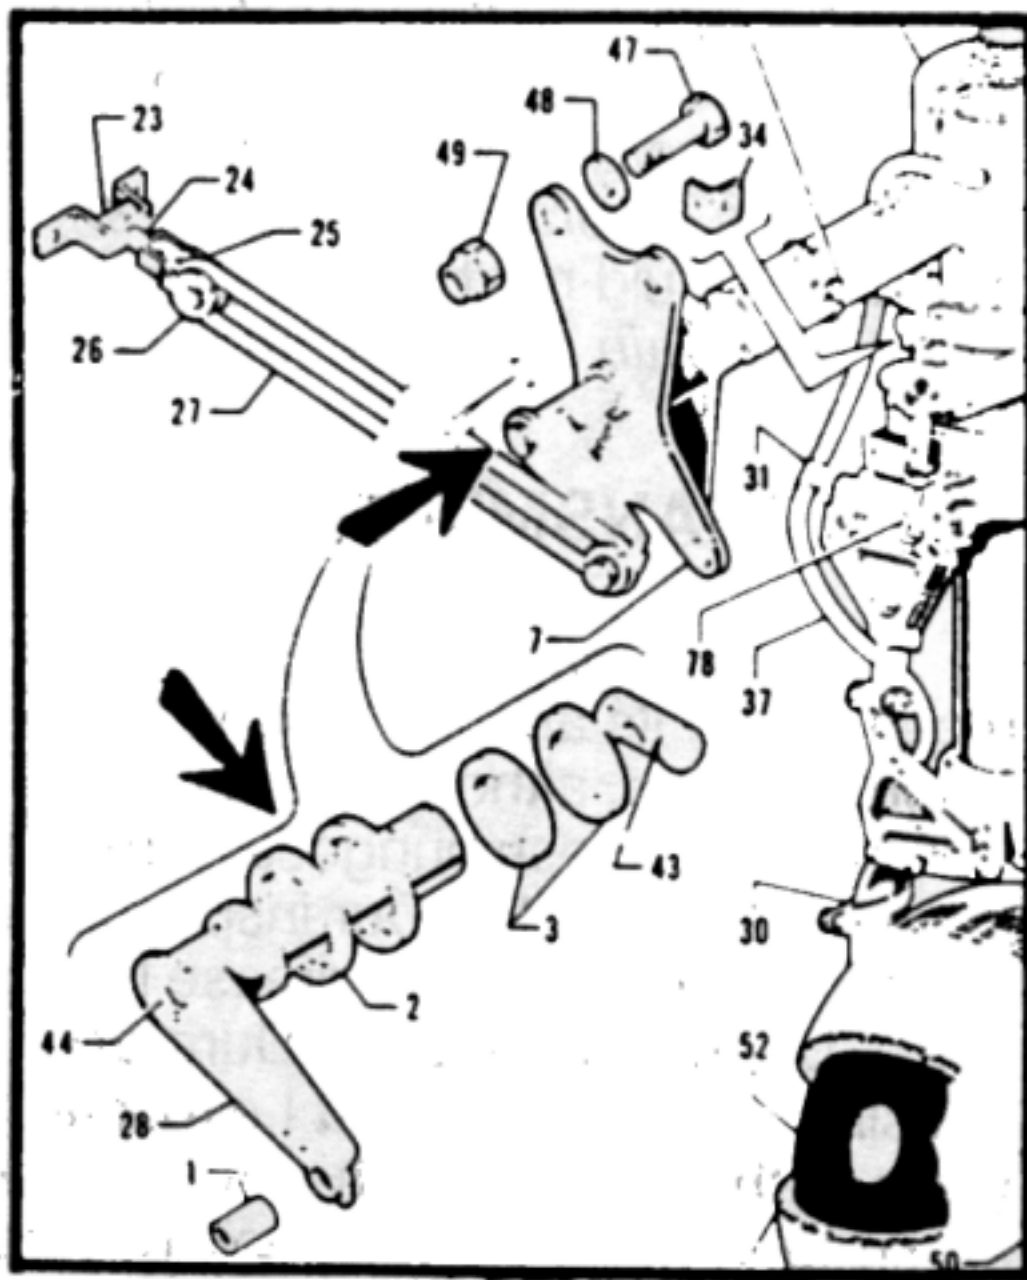
Pictured is the main landing gear showing arm (see arrows) and its position in the gear.

The newer arms have thicker walls even though they carry the same Piper part number.

I really question the FAA's decision of bushings being the culprit of gear up problems; rather suspect the gear transmission and this gear arm to be the main problem.

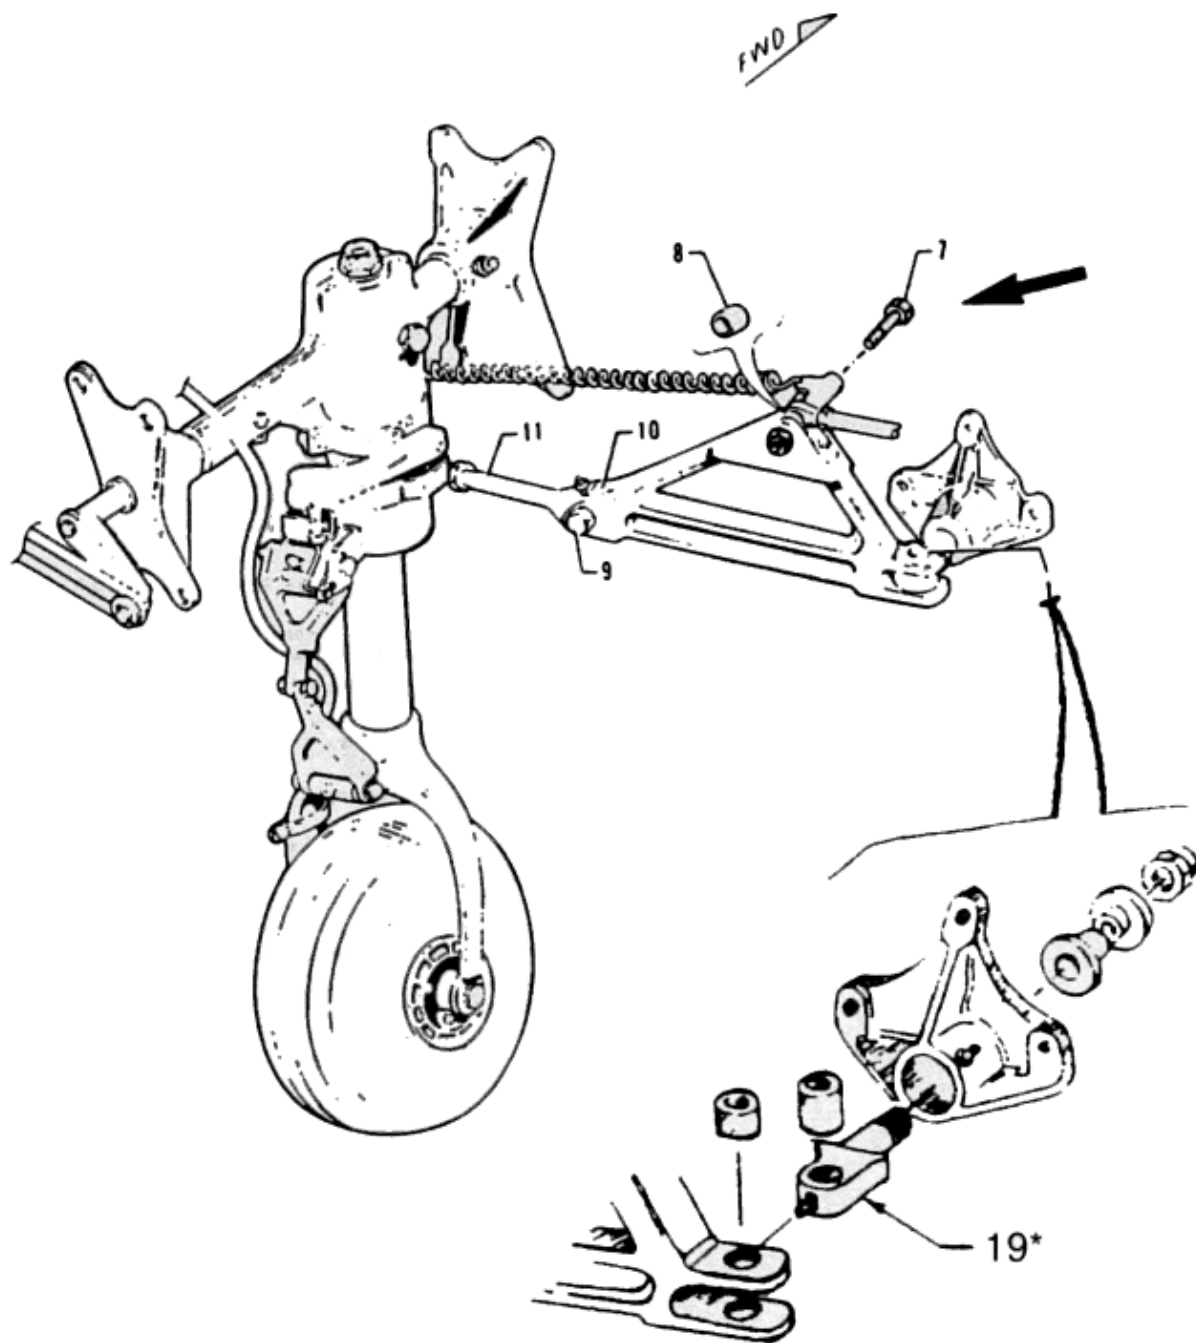
We have another item which you or your mechanic will need to check. We have found the bolt (item 7) installed the opposite way to that shown in the drawing. This will permit the end of the bolt to dig into the spar web as the gear goes up and down. It can destroy the spar. This bolt must be installed as shown in the drawing, i.e.; head forward, nut aft.

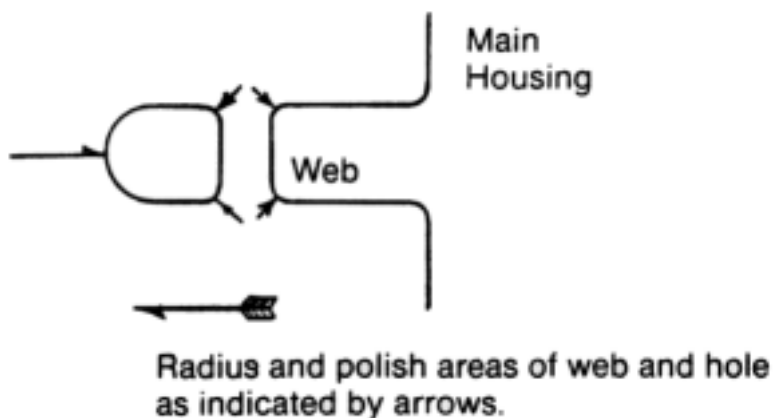
There are continuing incidences of cracks in Comanche main landing gear housings. To check for cracks, remove the bolt securing the clamp and slide clamp clear of web. Clean area in vicinity of hole and inspect for cracks visually with 10X magnifier or dye check. If no cracks are found, modify hole and web as indicated.

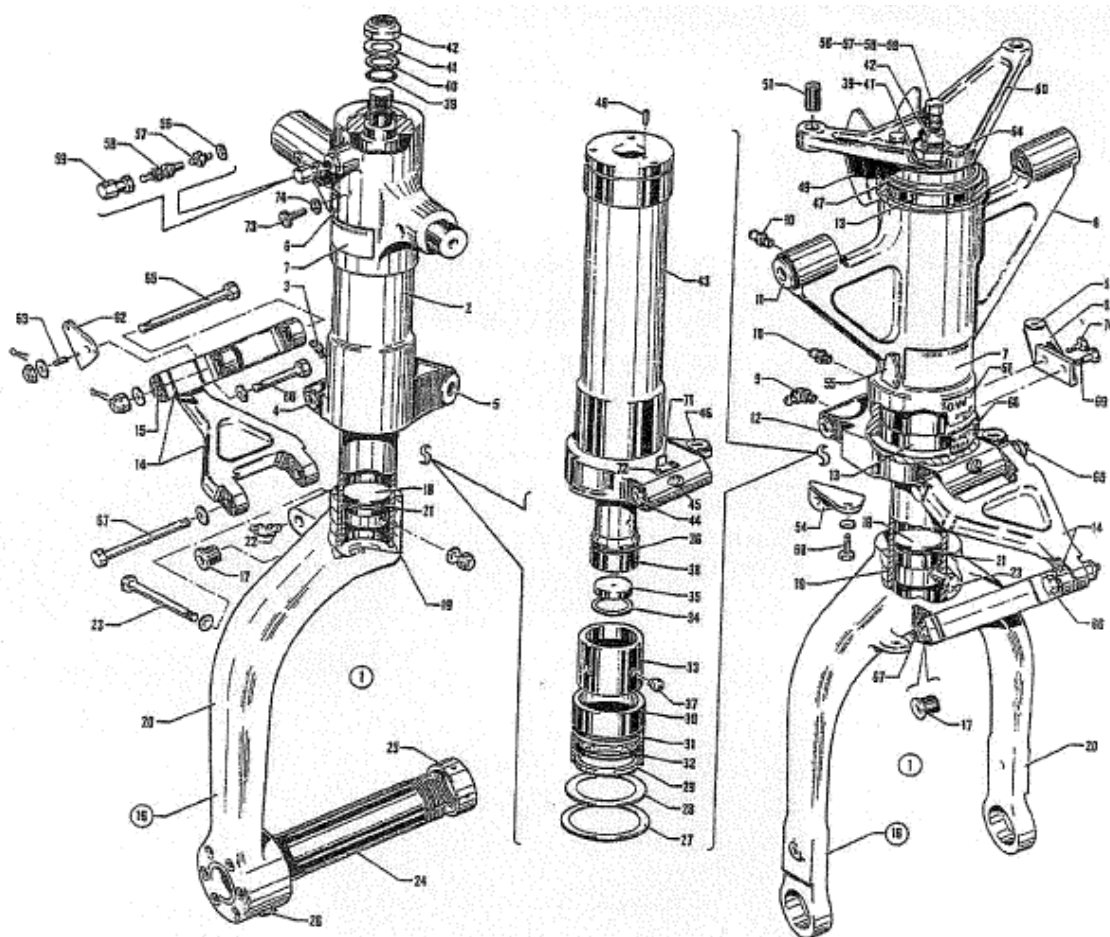
Fig. 1

Take a look at the gear strut exploded view in Figure 1 (I used a 260 single-fork diagram for clarity). What had happened was that one of the pins (#37) that secures the upper collar (#33) to the inner gear strut (#19) had aligned with the recess for the strut fill valve (#56-59) in the outer strut housing (#2). This allowed the pin to back out slightly into the recess and jam the strut!

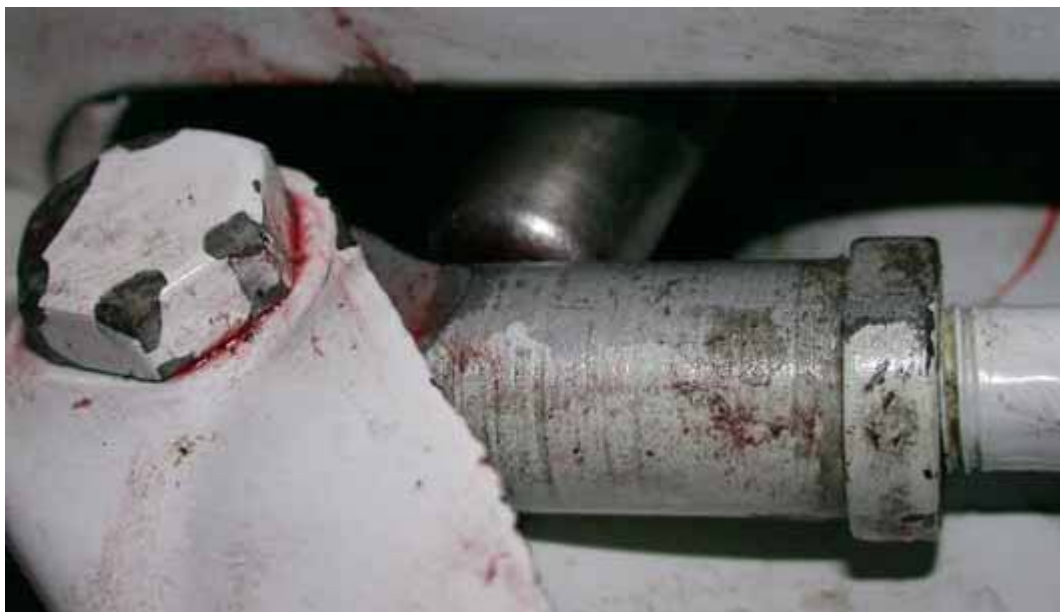
With this and dirty push-pull cables, and other loose or binding components, the gear will eventually fail. This is hard to lube and if a person is lazy it will not get lubed. The easiest way to lube it is while on jacks and to retract the gear. (This is being performed, right?) With the gear up about halfway, it's easy. For you who like to lube your own gears, it can be accomplished without jacking if you use grease fittings that "Snap-On" sells. It works well, or if you are careful you can get it with a flex tube.

The main landing gear side brace link assembly rod end. If lubed correctly, it should move freely.

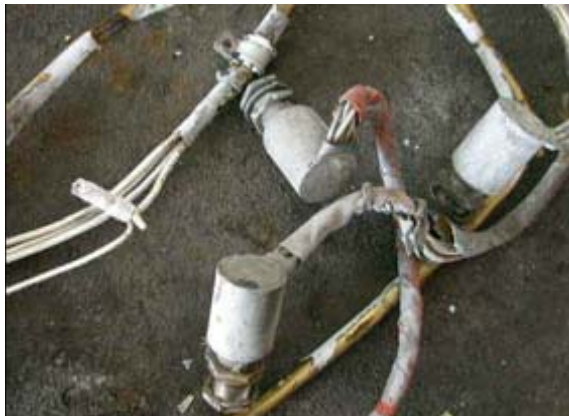
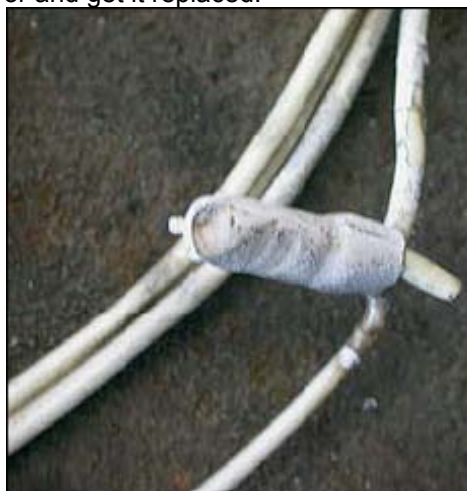
Here at Altus we replace the harness wiring and it takes about six to eight hours using the original switches. If you want everything replaced, Mat, at “Comanche Gear,” sells a nice, easy-to-install harness kit. Either way, take a look at yours: If you can see cracks and bare wire, do yourself a favor and get it replaced.

Gear harness assemblies after removal.

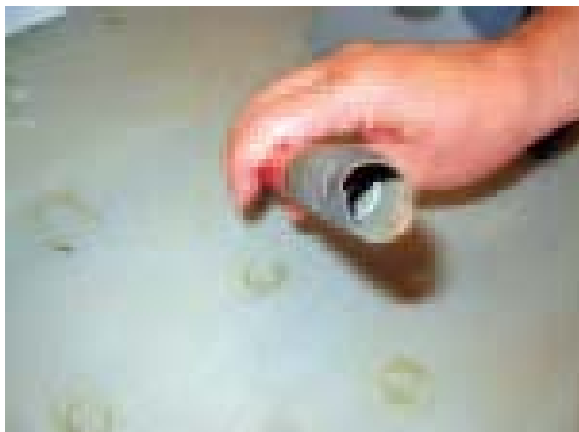
The three handles I looked at in these three inspections were crimped at the tip and would not even go into the receptacle. Simply put, had the gear not free fallen into the down and locked position in an emergency, these three planes would probably have landed gear up solely because the pilot could not have used the emergency extension handle to get the gear down. What happens sometimes in an emergency extension is that the pilot only inserts the tip of the handle a small portion of the way into the receptacle, and in forcing the gear down he deforms the tip.

Another look at a damaged emergency gear extension handle.

If you have a handle that looks anything like these photographs (crimped, deformed, narrow at the tip) then get it fixed or replaced. It must be in good condition to work, and who wants to damage a \$100,000 asset over anything as mere as a deformed extension handle.

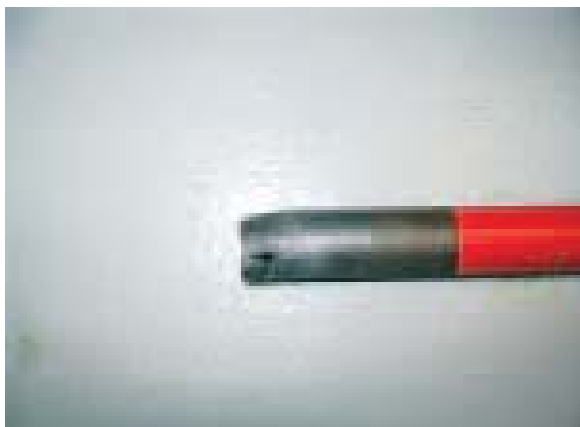
Check your emergency gear extension handle to ensure it doesn't look like this.

The repair procedure that I use is to put the handle on a concrete floor and force a tapered socket into the tip and hammer it home so the crimped end is forced open. I then insert a piece of pipe into the tip of the handle and gently tap-hammer around the edge so that the stretched metal is persuaded back into place. I then see if it will insert freely into the gear receptacle. If it does not, I work it until it does. When it does I lubricate the tip of the handle and the receptacle with some synthetic grease and ensure that it works in and out freely. If this won't work I won't sign off the inspection since the aircraft is simply unairworthy.

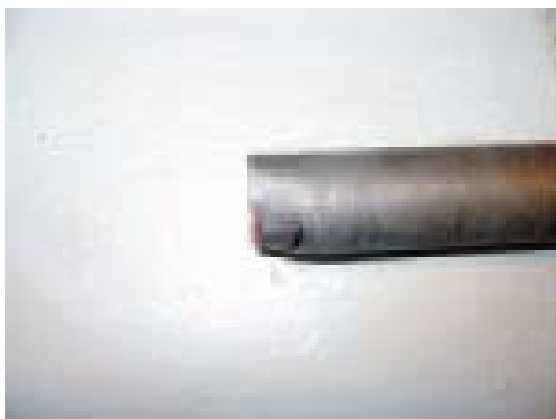
Crimped, deformed and narrow at the tip -- not how you want your emergency gear handle to look.
