## **Comanche Gear Conduit Replacement (Feb 2007)**

### **Llyn Fulmer, ICS #14577**

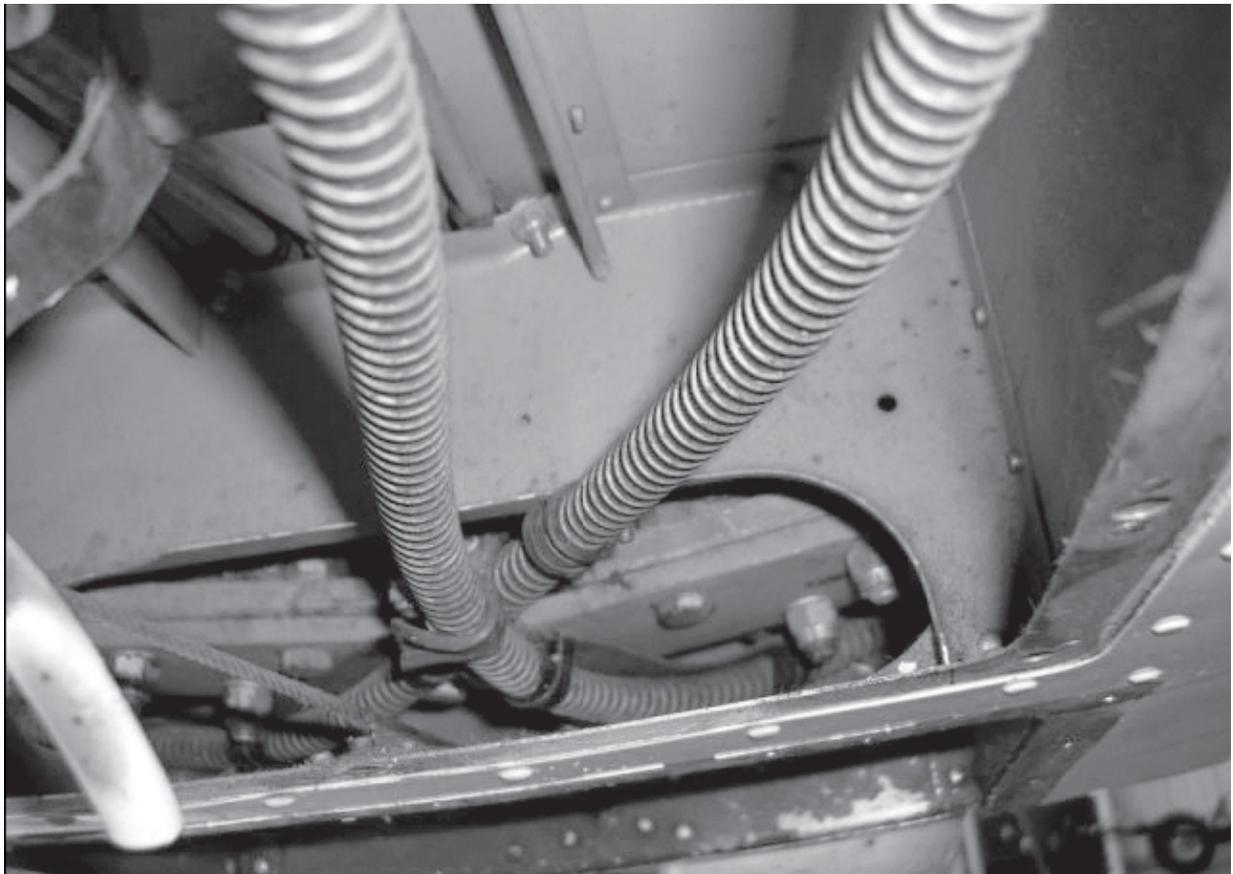
*Looking aft at the old conduit routing, the left conduit goes under the right one.*

After the old conduits were on the hanger floor, Dave removed the old gear cable from one conduit. It appeared that the old cable was not worn out. However, it appeared that just time and dirt had gummed up the interior to the point that it was nearly impossible for the cable to slide within the conduit.

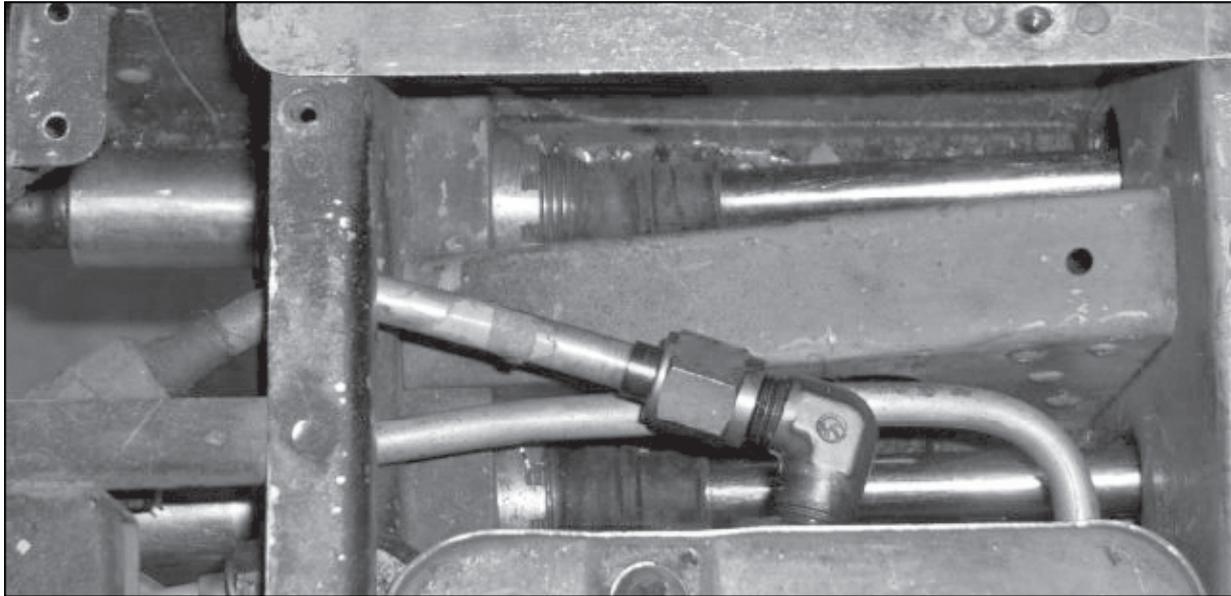
*The new conduits routed through the under-seat bulkhead.*

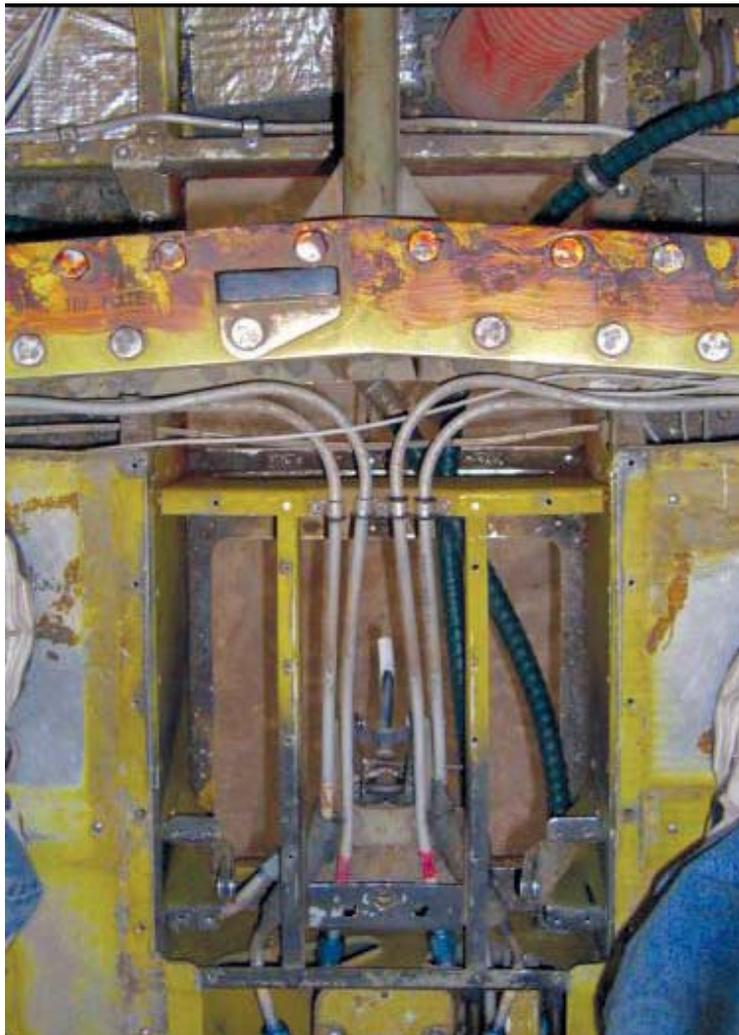
*A top-view look at the new conduits installed and routed.*

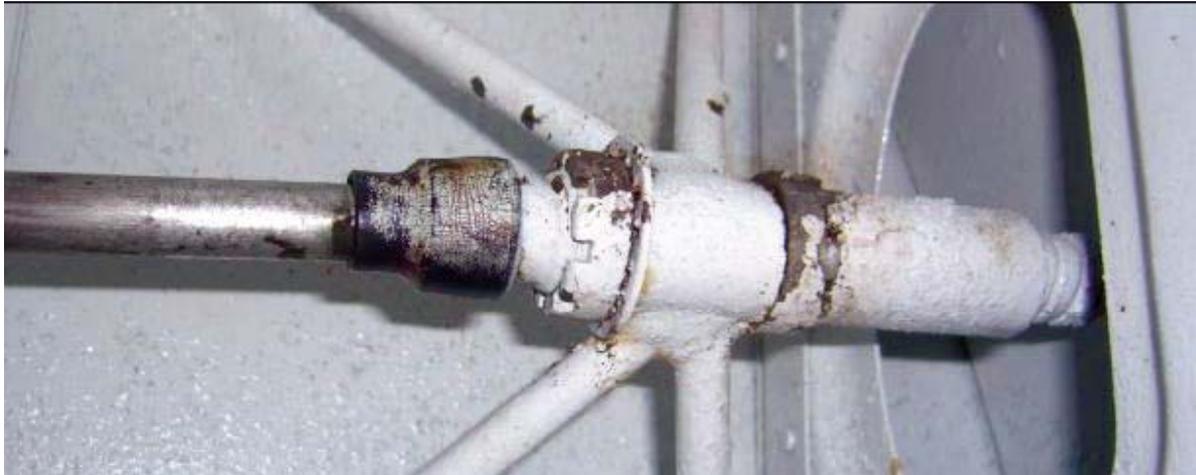
*The left side of the old conduit.*

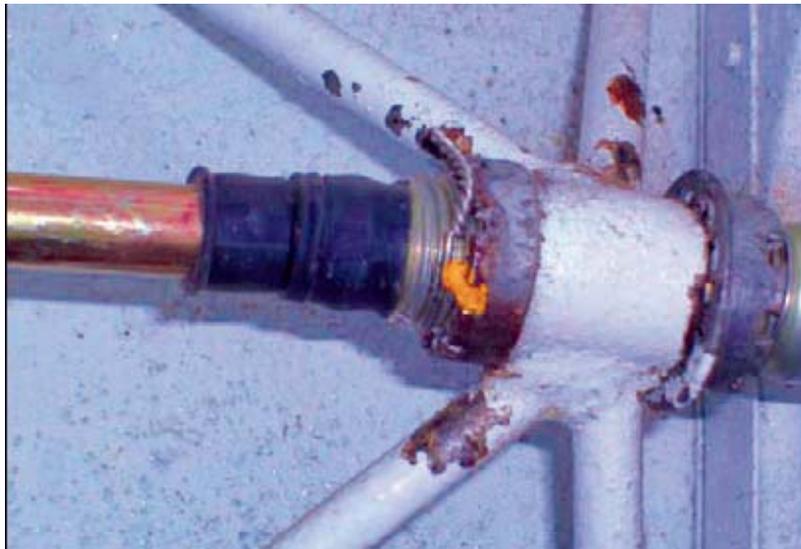
*The new conduit support collar.*
