CHAPTER EIGHT

AIRFRAME (CONTROL SURFACES, TRIM, SHEET METAL, FLAPS, GENERAL FUSELAGE)

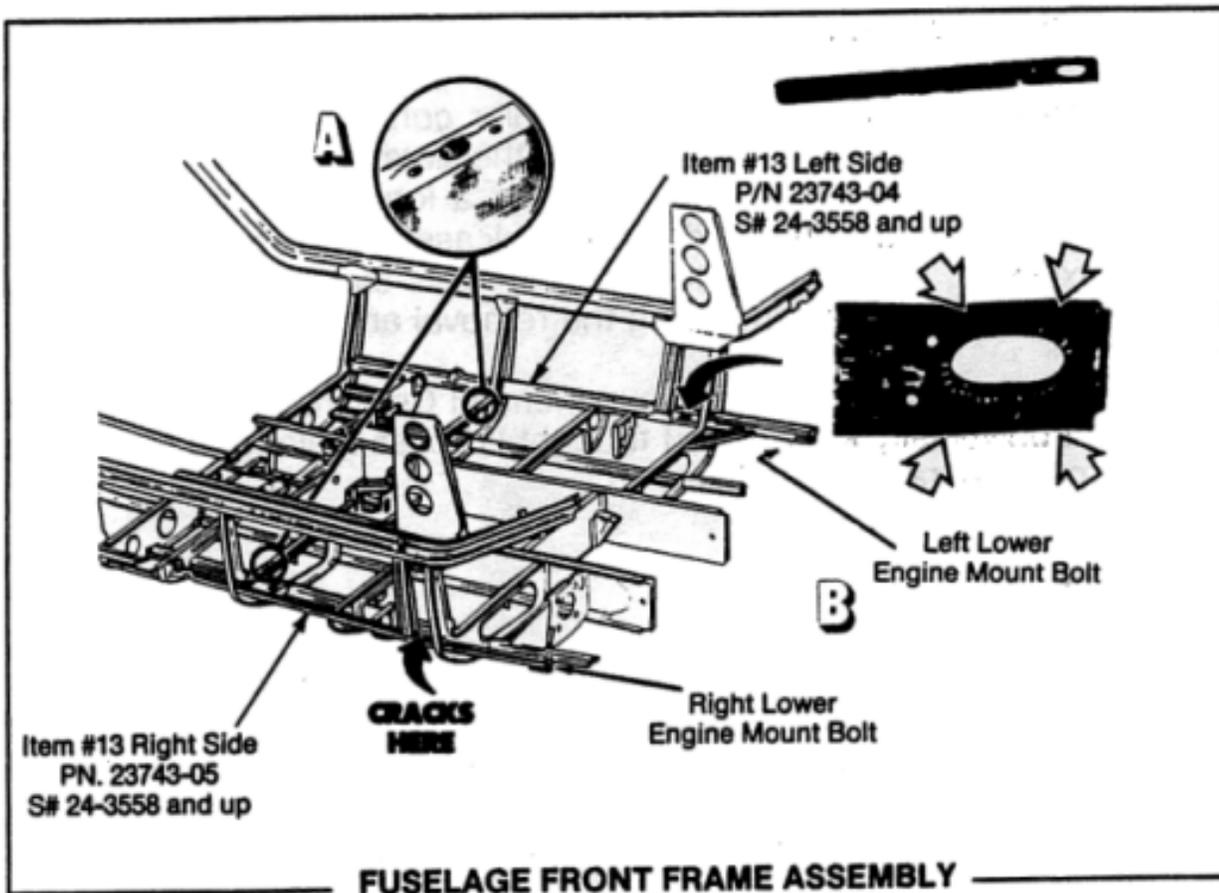
Seat Rail Bulkhead

One of our members, Eugene Chiappe, ICS #07578, advises that he found the bulkhead cracked where the plate nuts are attached, which hold the back end of the seat rails (See "A" on attached drawing.) He made this discovery as he was changing some insulation in this area. He told me that the previous owner had put in new carpeting and then mounted the seat rails on top of the carpeting. This allows the rail to move every time a person sits on that seat. The seat rail should rest on the floor panels with nothing in between. The fix was the removal of the nut plates, the cracks stop drilled, a piece of 1/2" x 1/2" angle was applied to the full length underside of the bulkhead and the nut plates replaced. I want to thank Eugene for finding this potential booby trap and calling it to our attention.

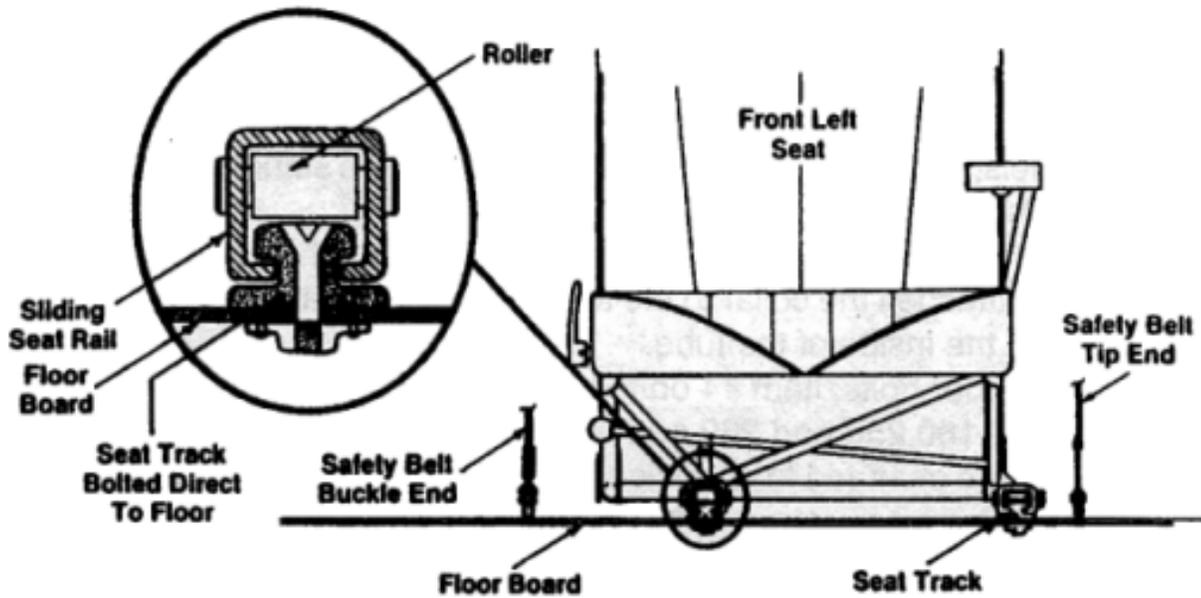
**Extract from Piper Drawing #26652
Seat Installation**

I am receiving many calls regarding the damage that this is causing. If yours are installed in this way, I strongly suggest that you get the rails down on the floor boards where they belong and inspect for cracks. Remove whatever is necessary to do this. But if you do not remove the carpeting from under the seat rails, plan at one of your next inspections to remove both side panels, take up the floor boards, which in itself is no easy task, and repair the damage. Then install the seat rails as shown in the drawing and this problem will not reoccur. This will require the completion of a Form 337 and FAA approval to return the aircraft to service.

I have included an extract from Piper drawing #26652 (See opposite page) showing the correct installation of the seat rails.

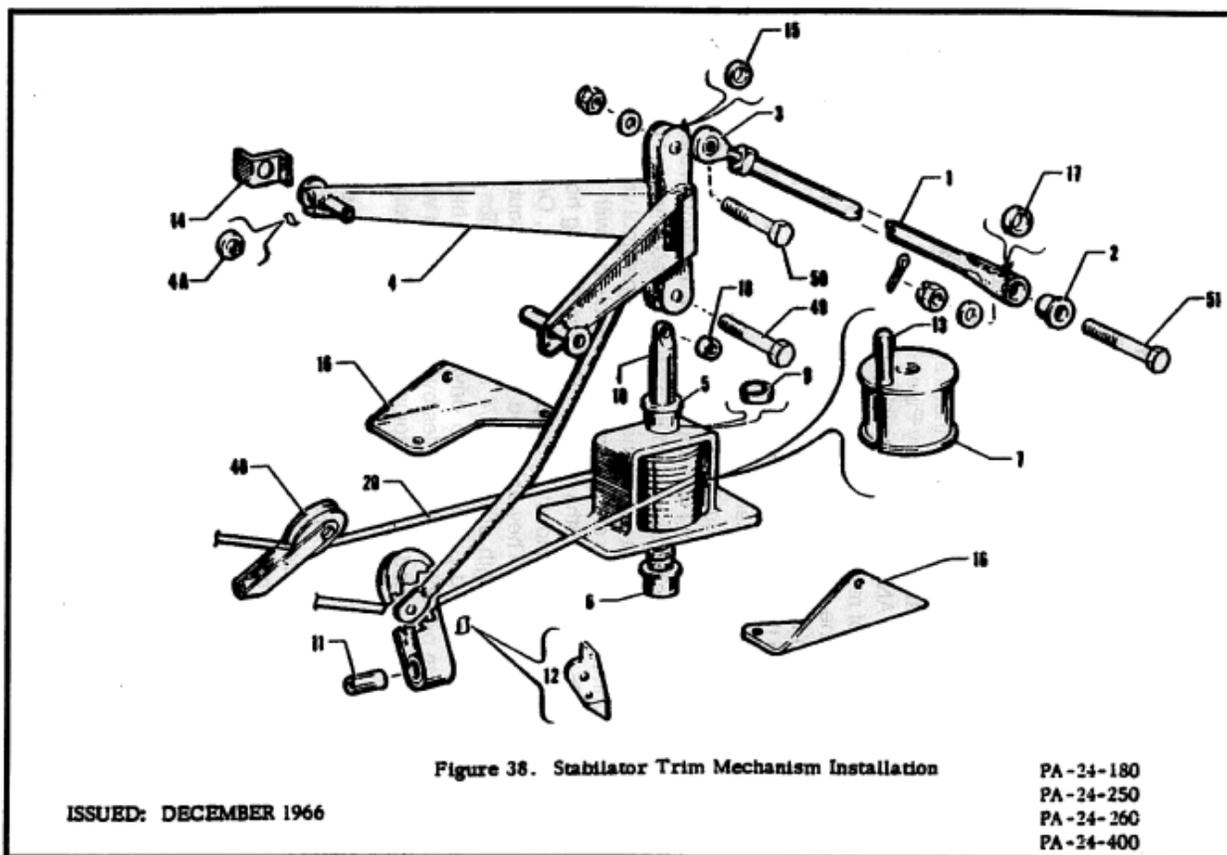
different, i.e., one is about 1/4 inch longer than the other. And yes, you guessed it, I had them reversed. The long one goes on the bottom and the short one goes on the top. (And, unlike the illustration in Fig. 38, the flanges on the stops should go next to the trim drum (#7). The bottom one in the illustration is correct, but the top one isn't.) I passed this info on to Maurice, and even he didn't know that the trim stops (#5 & 6) were of different lengths. They have no identification on them as to part number.

So, after I switched their position, and reset the neutral position, the actuator arm (#4) adjusted properly. We buttoned up the tail cone, flew the bird for an OK flight and signed her off. Learning experience, yes! But how was I so lucky the first three jobs to get those trim stops (#5 & 6) correct?

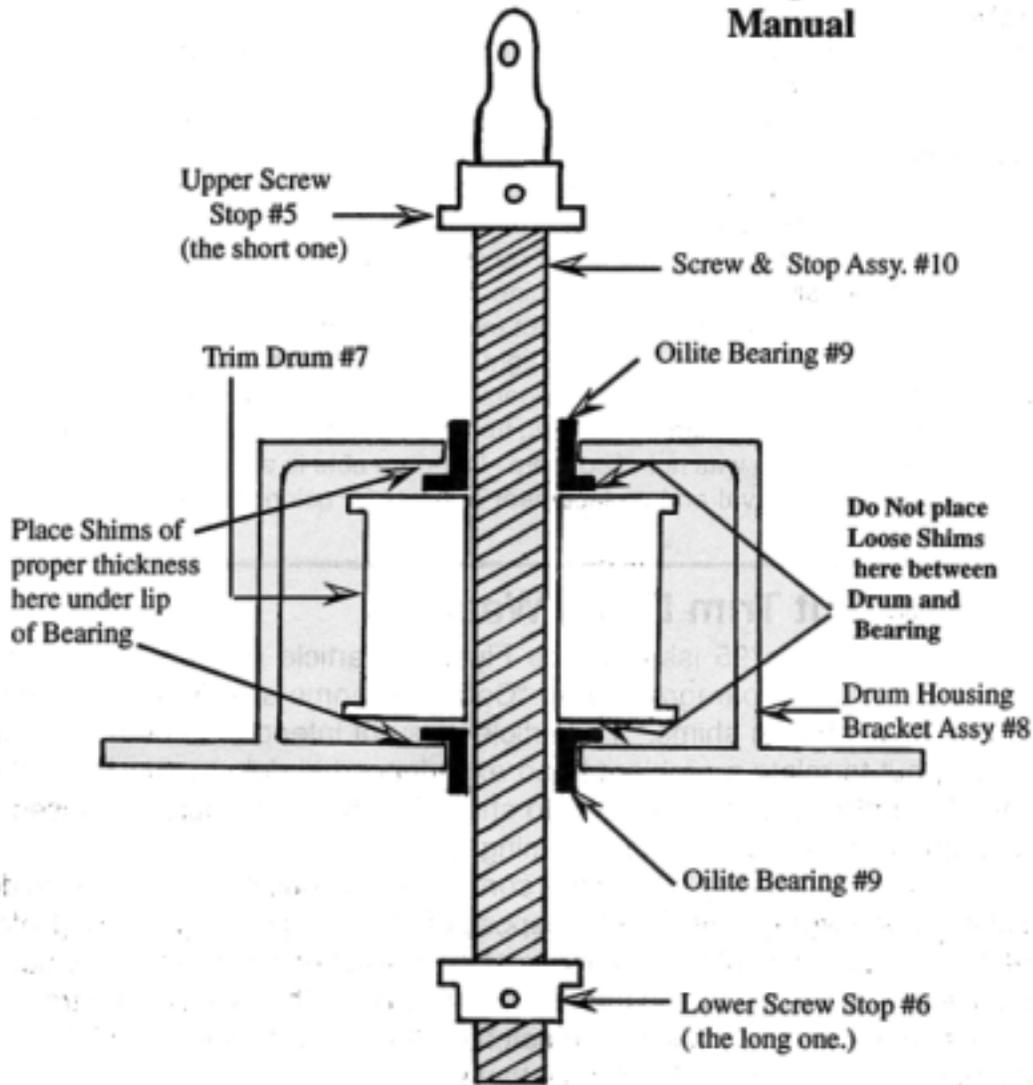
**Identification Numbers
refer to Fig. 38 in Parts
Manual**

In the January '95 issue of the Flyer, my article entitled "Errors and Omissions" referred (in paragraph 2) to "Corrected some slop in the trim drum (vertical movement) with shims." The article was not intended to be a "how to" type article, but to relate a problem I had experienced in doing a trim / stabilator overhaul. Nevertheless, the reference to shimming the screw actuator raised a couple of questions as to how the shimming is done.

oilite bearing (#9) and the drum housing (#8). Press the bearing (#9) back into the housing (#8) and reverse the whole process. In this way, the bearing (#9) will be displaced in the amount of the wear (shim thickness) and zero out the slop. Then assuming that you've attended to all the other wear points (bolts, bushings, and rod end bearings), you will end up with a snug, tight trim system.

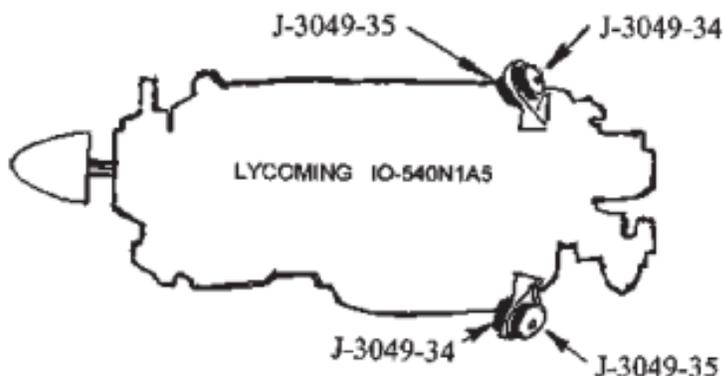
Note: There are differences in stiffness in the rubber compounds used in the sandwich mountings, so it is important to place the J-3049-35 sandwich mountings only in the top forward and bottom aft locations, and the J-3049-34 sandwich mountings only in the bottom forward and top aft locations.

Take the parts from these kits, which are the same as you'd have in four J-3049-30 kits, and have them installed according to Lord specifications, per the sketch below.

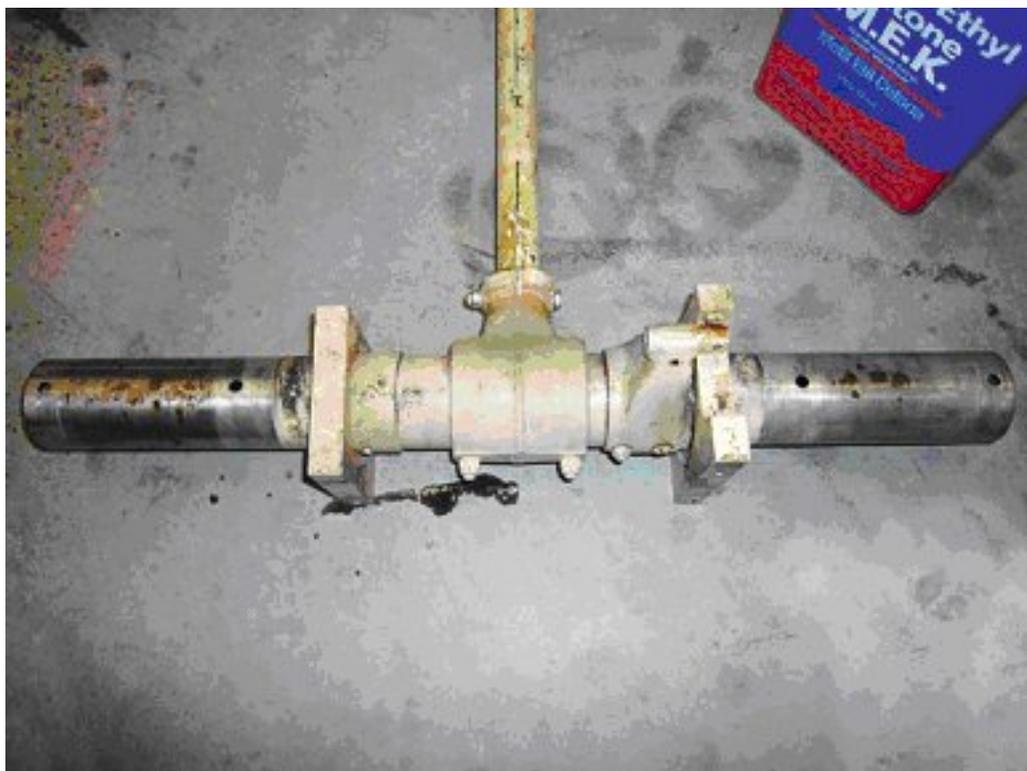
Service Bulletin 1160

In December 2005, Piper issued this service bulletin to address corrosion in and on the torque tubes. You can see very mild surface corrosion in the photo of the torque tube assembly below. In order to forestall an Airworthiness Directive, ICS member Hans Heubert, an FAA Designated Engineering Representative (DER), took the most corroded example available, and tested it to determine if the torque tube still met the strength standards required for original certification. The result was that even with significant pitting, the torque tube met or exceeded its original design requirements – proving once again that Comanches are generally over-built

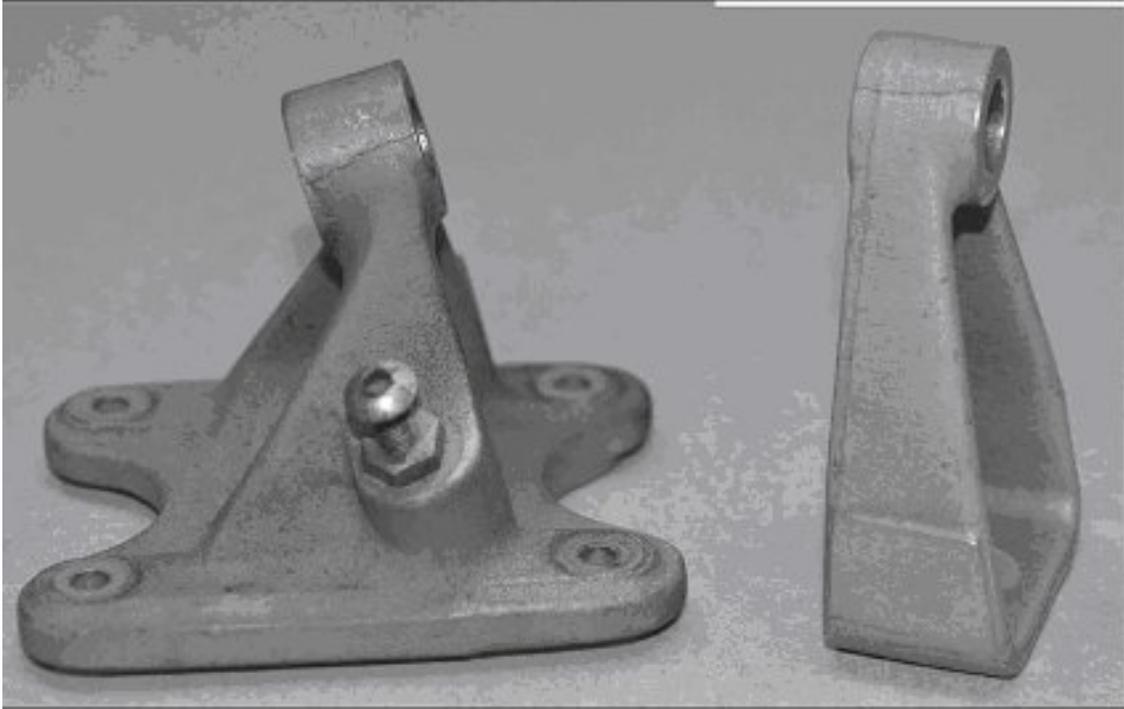
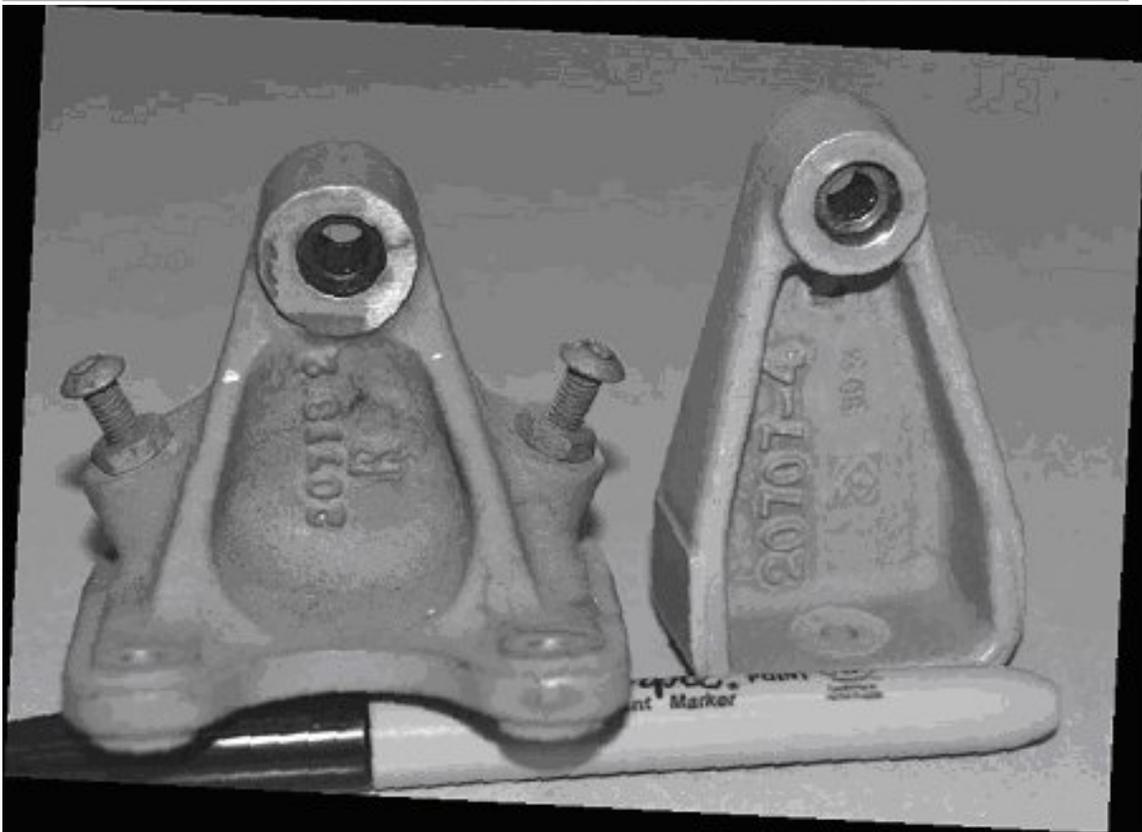
Service Alert Rudder Attachment (Dec 2009)

Inspection is difficult or impossible for the ends, but the sides of the boss that holds the needle bearing is easy to see. The FAA has two Service Difficulty Reports regarding these cracks on PA-24s with the -02 and -03 brackets.

The reports I have heard so far, were also in the PA-24s. It is unclear if this is a weakness in the part, or reflective of how the aircraft is operated. The only way to **properly** inspect these brackets is to remove the rudder. If your rudder has never been off, it might be worthwhile to remove it, at least once, in its service life to make an inspection of these critical components.
