The Comanche Flasher (Dec 2011) Friedrich Rehkopf, ICS #9153

However, the repair or replacement of some small items, like the warning flasher unit, is not that well known.

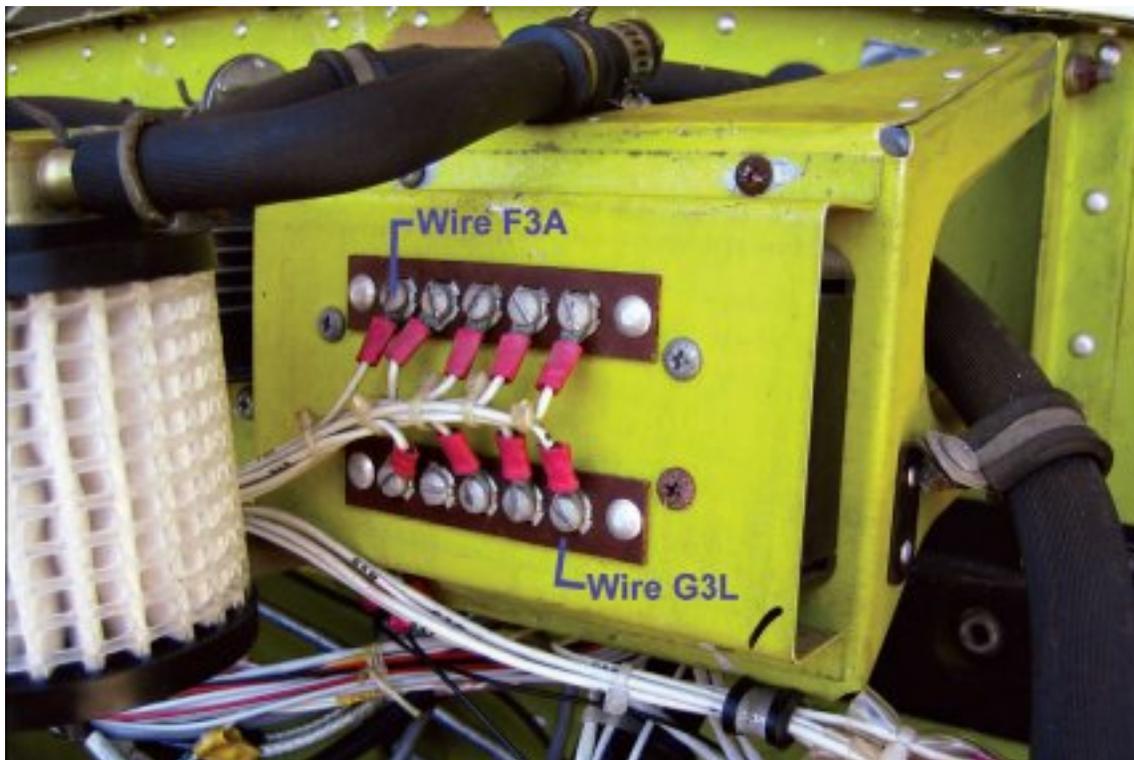
Figure 1: Flasher Box Assembly, F3A and G3L denote wire markings.

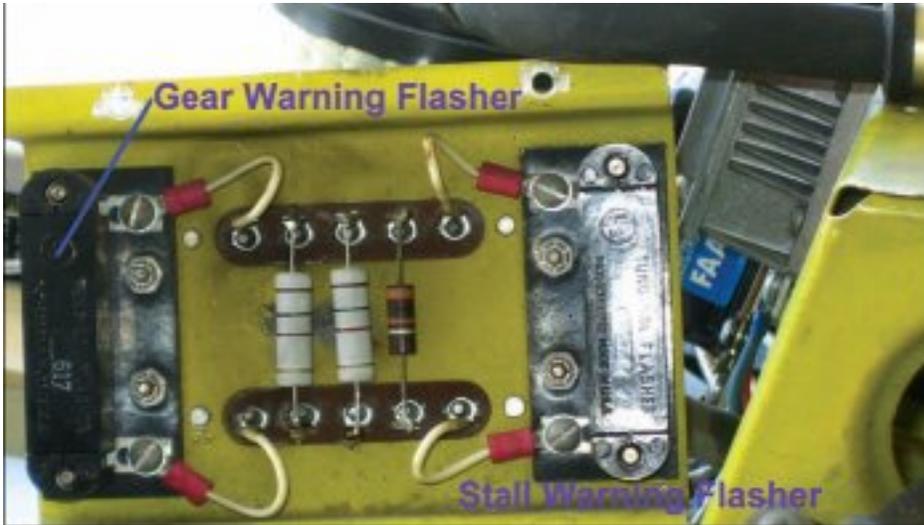
Figure 2: The flasher being used for stall warning and gear warning in the twins. Two resistors have been replaced earlier.

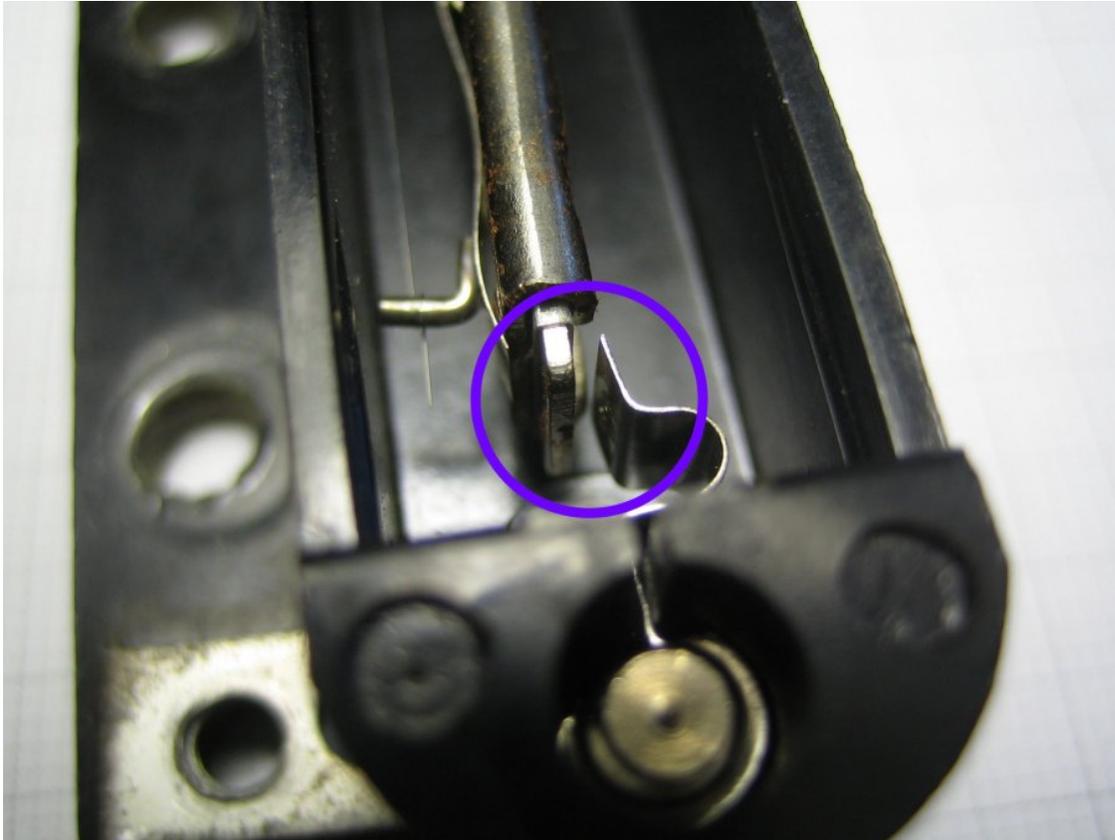
The flasher units (see Fig. 3) normally last a very long time. However, three types of malfunctions may arise. The most common problem seems to be a broken spot-welded joint between the very thin steel sheet metal strip that holds the flasher element in place, and the flasher element itself (Fig. 4). The second problem is that the contacts in the flasher element may become sticky and the force of the heater wire is insufficient to operate the contacts. The third failure is a burned heater wire.

Figure 4: Broken spot-welding

The broken spot-welded joint can be repaired primarily by soldering the pieces together. I personally would not recommend doing this because of the disparity in size of the two parts which may result in a sub-optimal solder joint and a limited service life. Sticky contacts are usually easier to fix. Just spray some electronic contact cleaner or similar solvent onto the flasher element, and after a minute or two, blow it dry with compressed air. If you find a burned thermo-wire in your 617, you will need to replace it.

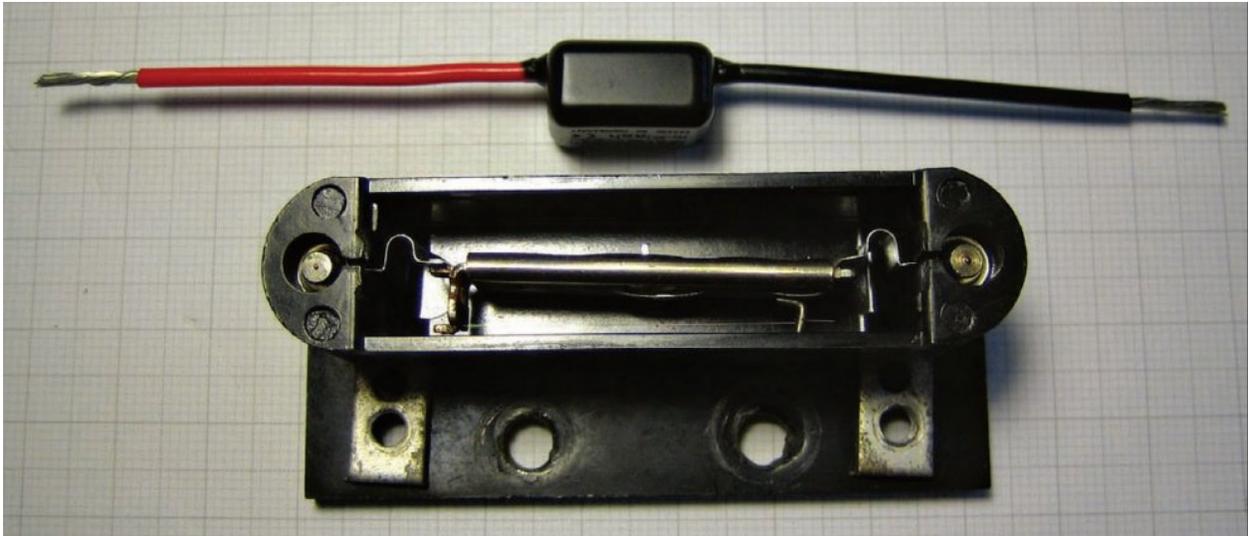
Figure 5: Open flasher housing with the solid-state flasher circuit.

1. Remove the old element by breaking off the spot-welded joints from the steel ribbon support strips.
2. Before soldering the m-Flash unit into the housing, two important items have to be considered. The first is the polarity. The red wire of the m-Flash must be connected to the positive side of the warning circuit. For twins, the POSITIVE side gear warning wire is labelled "G3L," and the equivalent stall warning wire is labelled "F3A."
The second consideration is the soldering process itself. Solid-state circuits can often be destroyed by excessive heat. When soldering the wires to the steel ribbon strips, heat up the sheet metal first to minimise the heat to the wires.

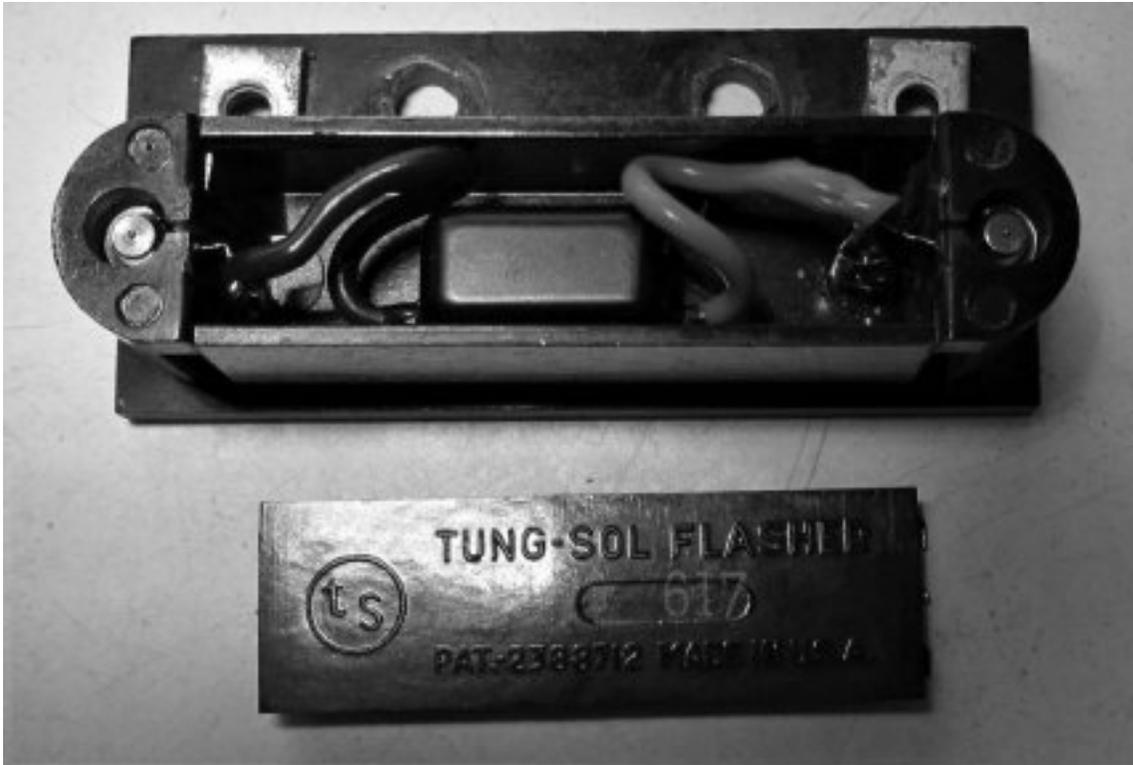
Figure 6: The repair completed with the solid-state flasher circuit inside the original flasher housing lid.

3. Position the m-Flash unit in the flasher housing, and solder the wires to the thin steel strips. Before soldering, double check for correct orientation of the polarity of the wiring. When the solder joints are cooled down, check the wires for firm connections. The last step is to apply a little bit of adhesive between the m-Flash unit and the flasher housing to stabilize it (see Fig. 6).
