Tips from Comanche *Flyer* magazines Feb 1973 – Sep 2012

## CHAPTER FIVE

### MAINTENANCE

### (GENERAL PROCEDURES, PAINTING, PLANNING, CORROSION CONTROL, HANDLING)

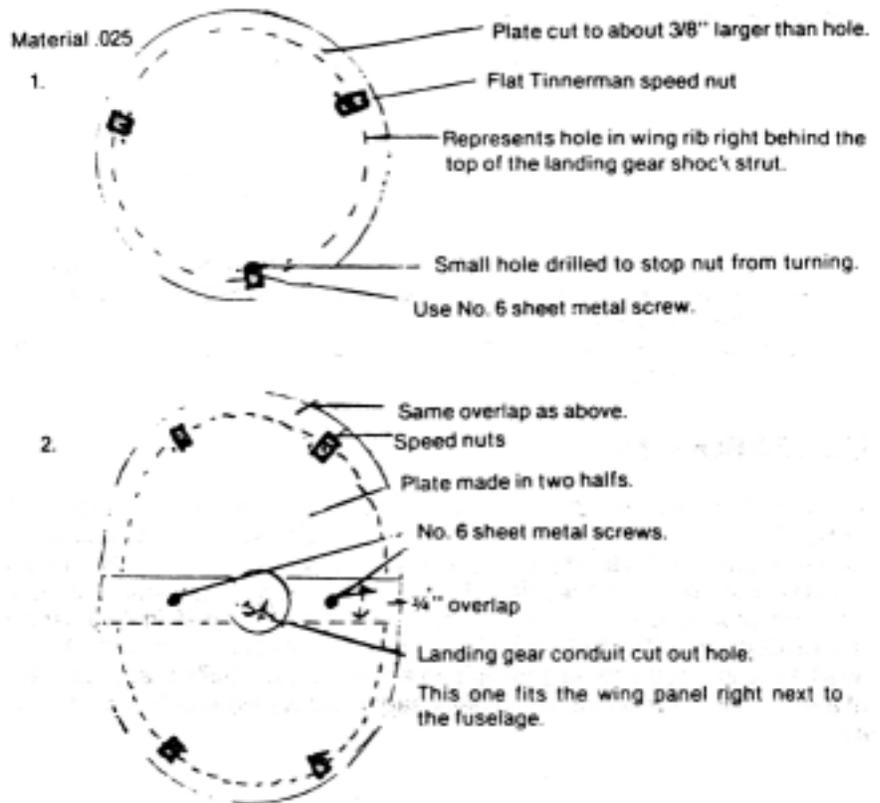
I remove the original wheel well baffle shields that were made of too light of material and soon cracked from the air pressure that is built up in flight. I make new baffles out of .025 using the old baffles for a pattern, also trim so that the baffle fits close enough to not let the mice in. I also glue a good quality flexiblefiber cloth to the top of the baffle.

This seals out dirt and grass etc. from getting in the wing area.

This is a rough quick drawing, but it should describe it.

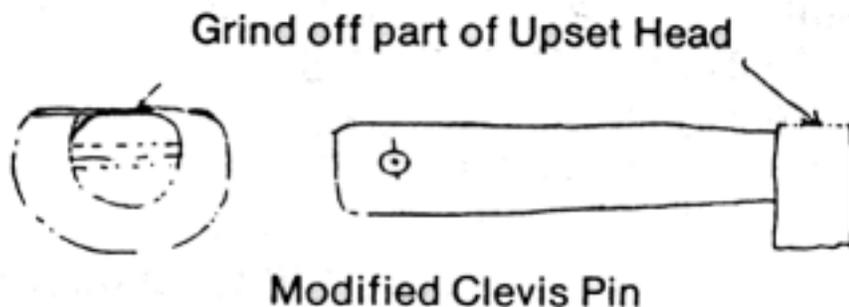
If you haven't already received this tip, it might save someone some unnecessary expense. One of the hinge pins on the cowl latch (Piper P/N 12723-004) on our PA-24-260 broke off at the cotter pin hole. A check with the Piper parts distributor revealed that the pin was unavailable as a piece part; only the entire cowl latch assembly (number above) could be obtained, at a cost of \$22.65. A kind hearted mechanic showed me how to make a replacement pin using a standard clevis pin, Part No. MS 20392- IC-23, also available as Piper Part No. 424149.

One simply grinds off one side of the upset head on the clevis pin, to match the existing part. Note that on the Comanche 260, the flat face must be ground off approximately parallel to the axis of the cotter pin hole; otherwise, the hinge assembly interferes with insertion of the cotter pin.

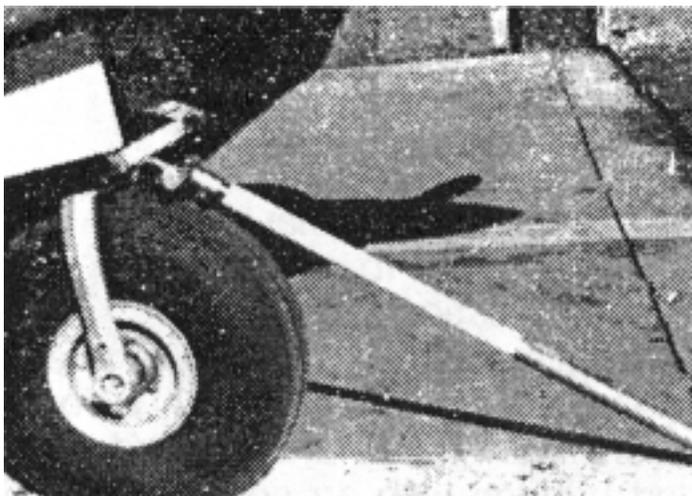
I did get out my tow bar that I made several years ago. The bar is basically the same except I changed the hooks a little, but the important difference is that on the lower side of the bar I welded a piece of three-quarter inch aircraft tubing crosswise in such a position as when one lets go of the bar it will fall down and the hooks raise out of the steering fork lugs and fall free; thus there is no chance of the prop striking the tow bar or taking off with it stuck in the front fork. The savings here can be very worth while.

Pictured right is the tow bar that Steve modified.

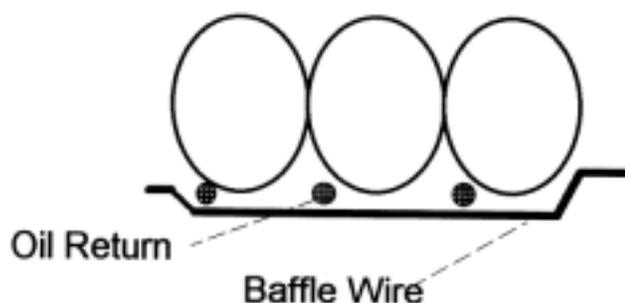
Here is a problem that I detected with careful looking on my Comanche 260, which has an IO-540 Lycoming engine. Under the cylinders on both sides there is a 1/8th inch wire rod which holds the front and back baffles against the cylinders. This rod has a bend, but runs across the two rocker cover oil drainback tubes under the cylinders. I found that the wire rod had cut into the drain tube. When I pulled down on the wire rod, oil leaked from the tube. The steel rod had worn about 1/3 of the way through the aluminum tube. The rod effectively plugged the leak, so unless I pulled down on the rod I wouldn't have noticed this. Eventually, the wire would have sawn through the tube and an oil leak would have resulted. I will bend the rod more and add a small rubber hose to protect drain tubes. However, I suspect that the baffles are incorrectly installed as it seems that the wire should not be so close to the tubes.

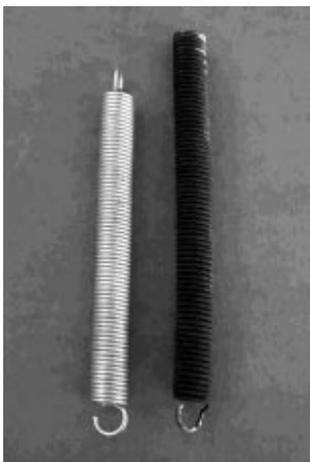
The reason his flaps didn't come up was that he cleaned his flap tracks and rollers, and they were very dry.

*Pictured here is a flap spring, which if not kept in good repair, can lead to an asymmetrical flap situation.*

I know the book states that the “new” rollers don’t require lubrication, but I disagree. If I clean the tracks because someone has slopped grease on them (which is a no-no), I apply a light lubricant. Then they don’t stick. It works quite well.

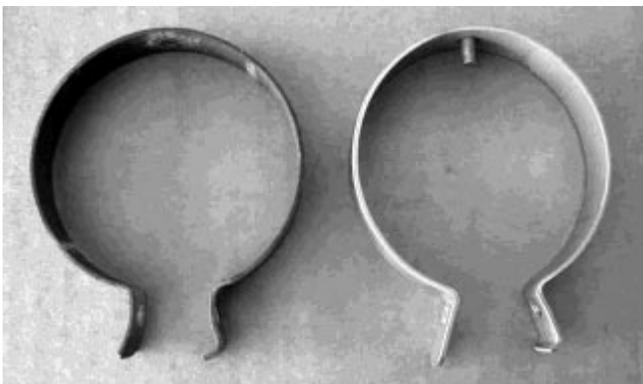
*Check exhaust clamps for wear. Here’s a side-by-side comparison of worn and new clamps.*

Another item to check is the exhaust clamps that are on all the Comanches except the twin. If you look at the pictures, you will notice a post that sticks out on the clamp.

This is made that way because there is a hole in the two pipes that attach to each other. This holds them in place and keeps them from coming apart. The tail pipe also has one and without it, the tail pipe can fall off. I have found many with the pin worn a little and has actually started to rotate to the point that the hole is egg shaped. I have also found where the pin had broken or worn off and the previous installer put a screw in its place.

The clamps are expensive, but what is a life worth? I have taken these clamps and had a stainless steel pin welded back. This works fine, but don’t put a screw in it or put in back on without the pin. And when putting the exhaust back together, apply “Never Sez” to the slip joints and exhaust stud, and they will come apart with no problem next annual.

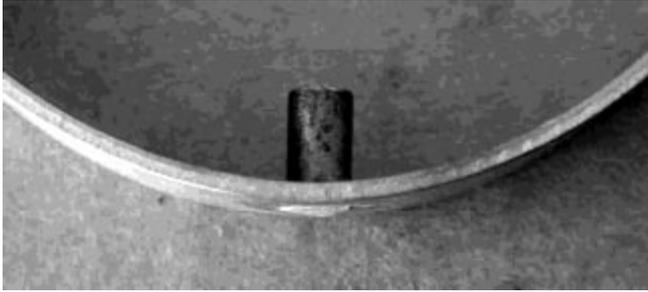
*Close-up of the exhaust clamp pin.*
