# Main Gear Doors (Apr 2009)

## 6-39: Adjustment of Main Landing Gear Door

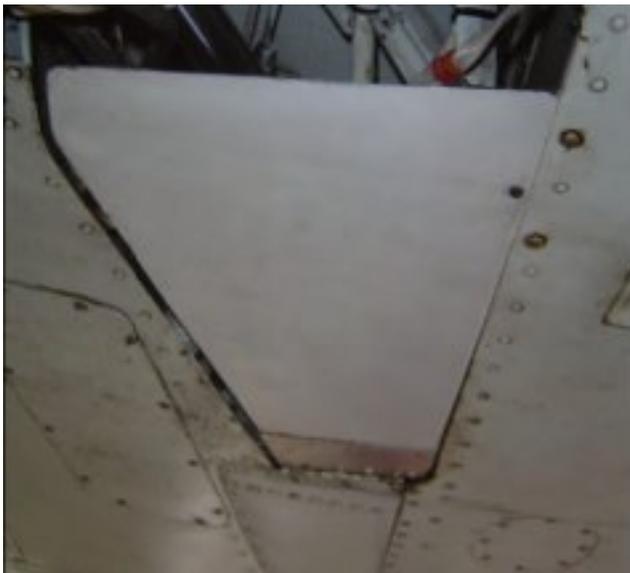
*“Ascertain that there is an all around even clearance between the door and wing panel when the door is in the retracted position”. This is a good example illustrating a poor job of fitting the door after a repair.*

**Note c:** The 0.125-inch deflection means exactly that; you must have some deflection or the closure load on the door is excessive. Excessive, and you may have a bent bracket, and stress the gear door near the hinge causing a crack, which is why you typically see that ugly patch repair at that location, which appears in the first photo.

**First Trick:** Remove the AN4 bolt from the upper end of the gear door retraction rod. With the airplane on jacks and the tail tied to an adequate weight, retract the landing gear and remove the offending door. The door removal is done with the gear retracted because that way the strut is away from the area where you need access with your hands and tools to remove the hardware. With the door removed and on a suitable work area, drive the old 0.116-inch diameter pin out of the hinge. Mount the hinge half in a vise, make sure it is straight, and then drill through the pin bore using a **long** #30 drill bit with some lubricant; repeat for the door portion of the hinge. Procure a 1/8-inch (0.125-inch) diameter tempered stainless steel welding rod and cut a piece exactly four inches long; deburr and chamfer the ends, and you now have a new hinge pin which will greatly reduce that loose feeling. Apply a little grease to the pin and assemble the hinge. Close both ends slightly to retain the pin; don't get aggressive with this, a little will do.

Temporarily reinstall the door using the hardware in the center position hole only. Note: Use #10 AN525 washer head screws with a shank length adequate to capture the total thickness of the rib, hinge, and the skin. Keep in mind that you will need to use A MINIMUM of two #10 thick washers at each position; otherwise the nut will bottom against the shank portion of the screw before clamping the assembly (this is a very common condition from the factory). Don't use fully-threaded screws or bolts here.

**Second Trick:** Position the door in the opening with a little aft bias (see note below). Using a fine-line marker, mark on the hinge through the holes in the wing skin where the hardware was removed; again remove the door. Using a 1/8-inch carbide burr and a high-speed rotary tool, or rat-tailed file, enlarge the fore and aft holes in the hinge to the marked positions. Please don't drill those holes larger; you may end up with a mess.

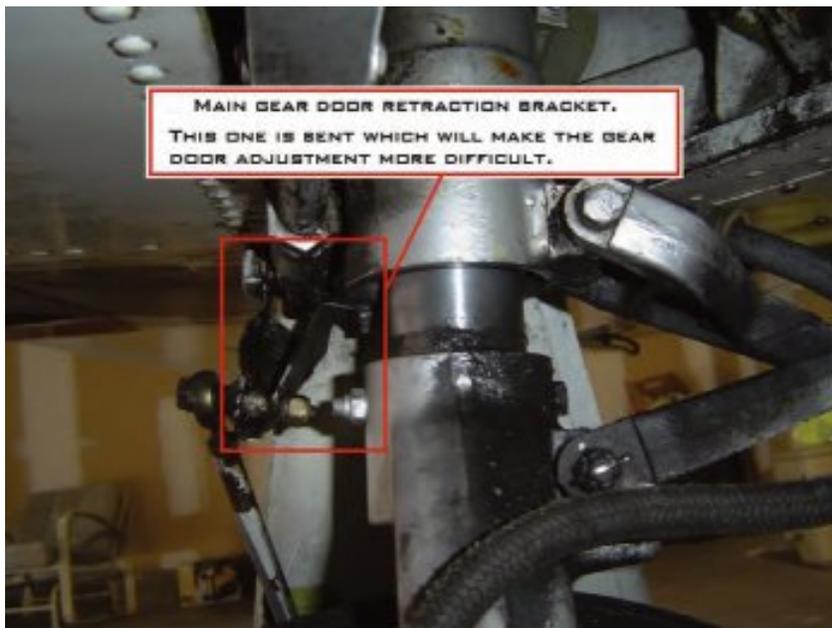
*If you have a bent bracket, now is the time to rectify that condition.*

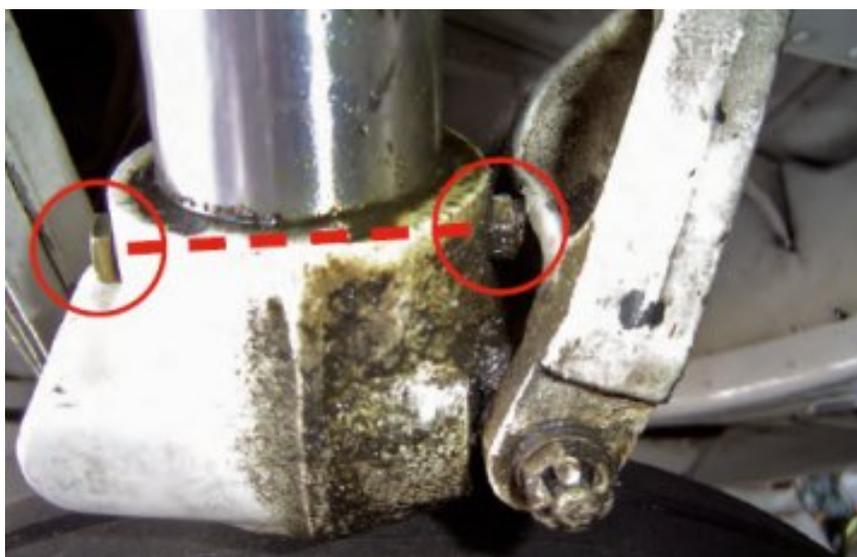
This bolt (left) is installed backward causing the nut to interfere with the torque link which then does not allow the strut to extend completely. The result is shown below, a torn tab at the gear door up-stop.

Another less common condition is improper orientation of the AN4 bolt at the gear fork where the strut oleo tube fits. If that bolt head is not aft, the lower torque link will touch the bolt. Then the oleo will not fully extend and the pivot between the torque links will be too far aft and consequently contact the plate and bend it upon retraction. This can be assembled incorrectly after tube replacement or other service/repair. Another cause is retracting the gear with a deflated/compressed oleo.

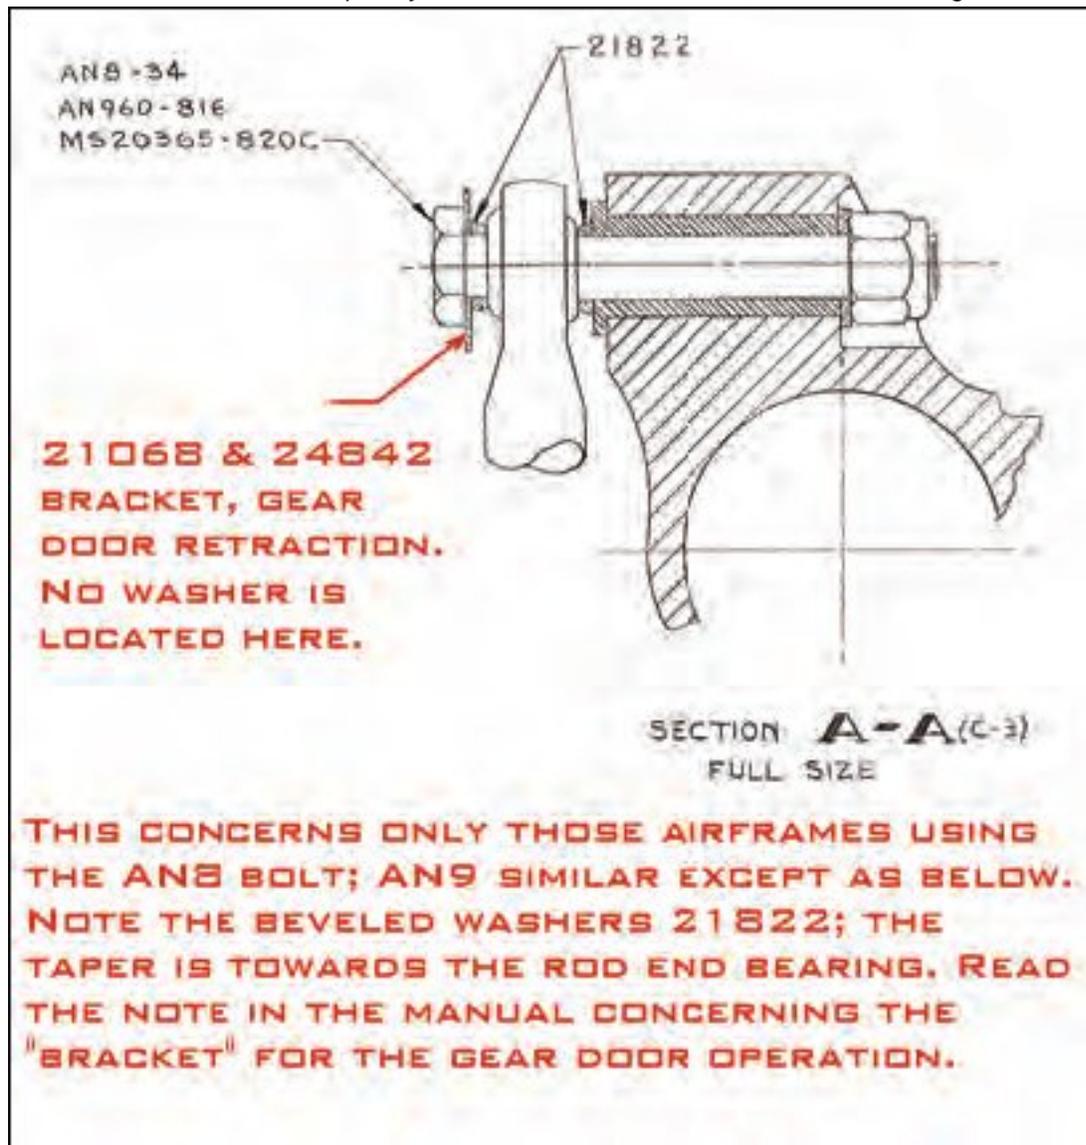
Section A-A (above) is a typical Piper assembly drawing. Check the torque on the hardware where the long bolt attaches the rod end bearing to the strut. If that bolt, either AN8 or AN9, is allowed to rotate from inadequate torque, then the gear door retraction bracket likewise can move during the retraction operation, thereby disallowing proper gear door adjustment. Also look for a bent bracket which is quite common after 45 years of service. The torque values for the long bolts are: AN8 = 480-690 in-lbs dry; AN9 = 800-1,000 in-lbs dry.

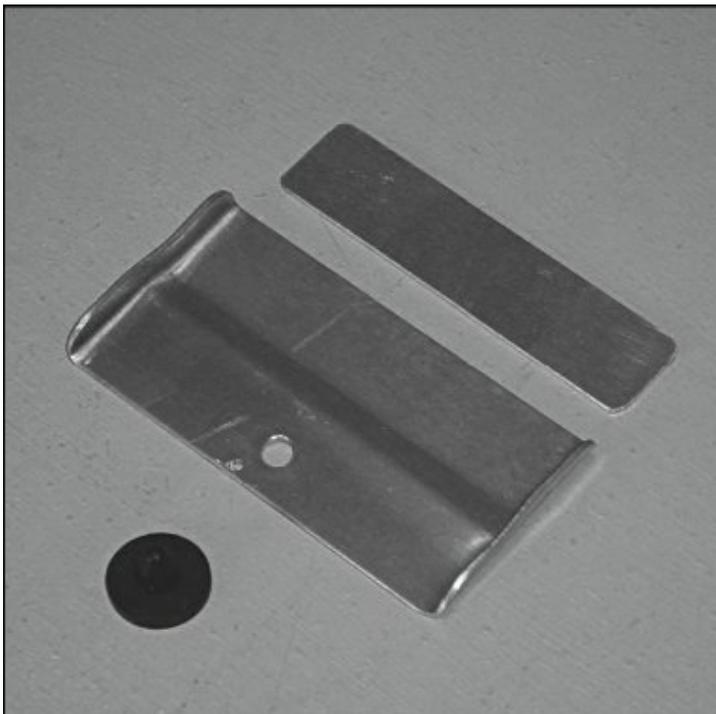
*Fabricated main gear door stop plate with doubler. The 3/16-inch hole is for the rubber stem bumper.*

This plate is not to be found by me in the parts catalogs (I have wasted way too much time looking; but it has to be there!), and one would assume it would be like so many other Comanche parts, NLA. So I had a fabricating shop make a set of forming dies to duplicate the plate including the joggle; I felt a doubler was a good addition. Since this would be an unapproved part from me, it might be a good idea if you did the "owner-produced" route by fabricating your own - that's called a disclaimer in legal parlance.

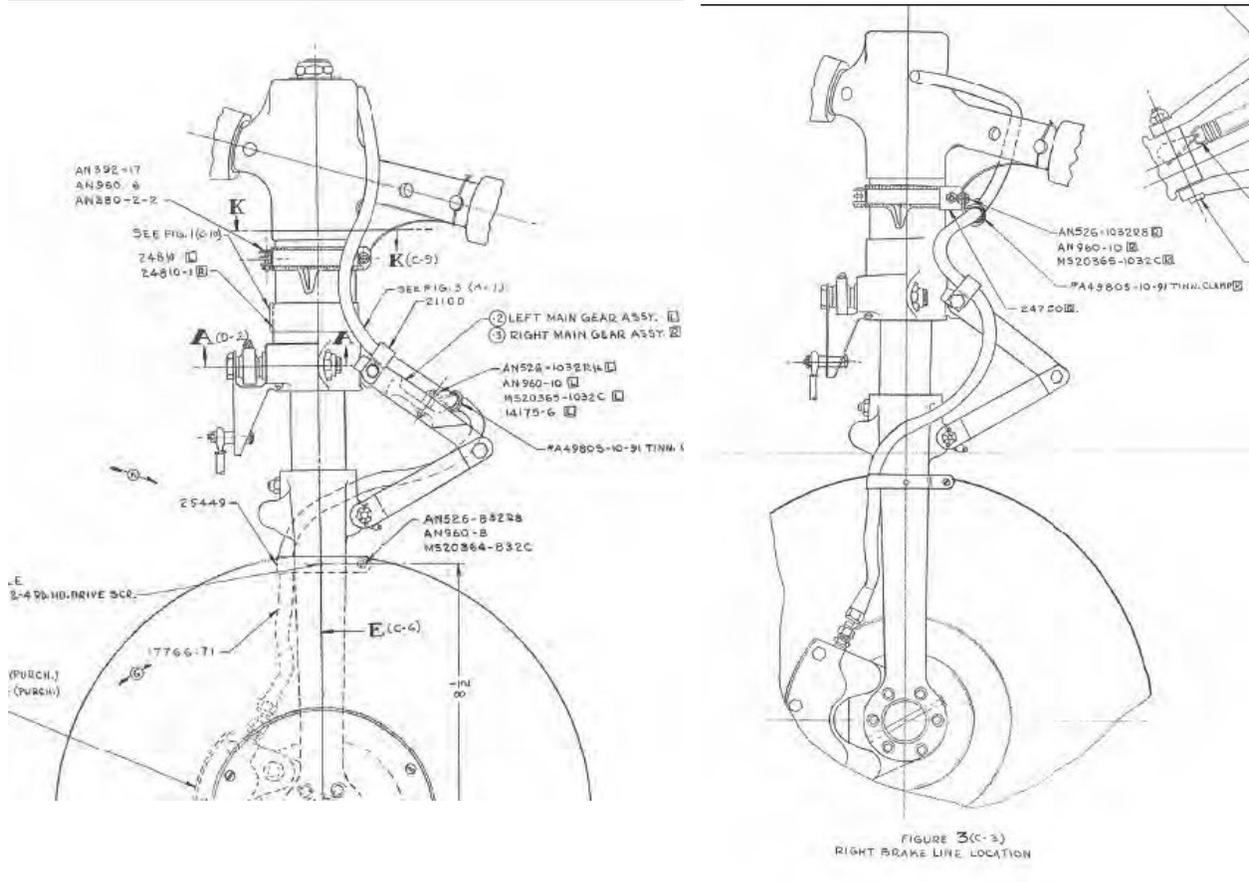
Left-side brake line location (left) and right-side brake line location (right) from typical Piper assembly drawing. Note this routing applies to the single-fork gear which has the brake calliper on the inboard side of the wheel.

The most common cause of damage to this plate is from improper routing of the brake hose. Possibly when the brake hose is removed and not properly routed and secured when reinstalled, it can foul that plate upon gear retraction. See the damaged plate (photo on page 25, top and the drawing insets pictured top right).

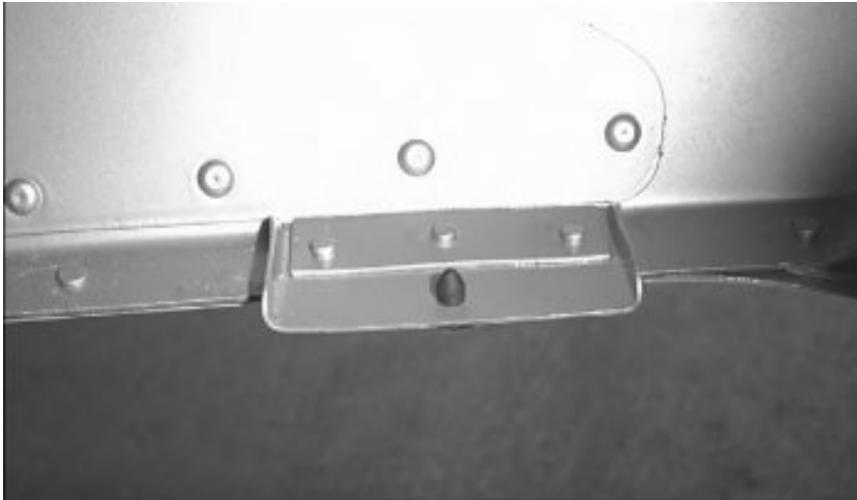
*Plate, main gear door stop repair showing added doubler*
