CHAPTER TEN

INSTRUMENTS / NAVAIDS

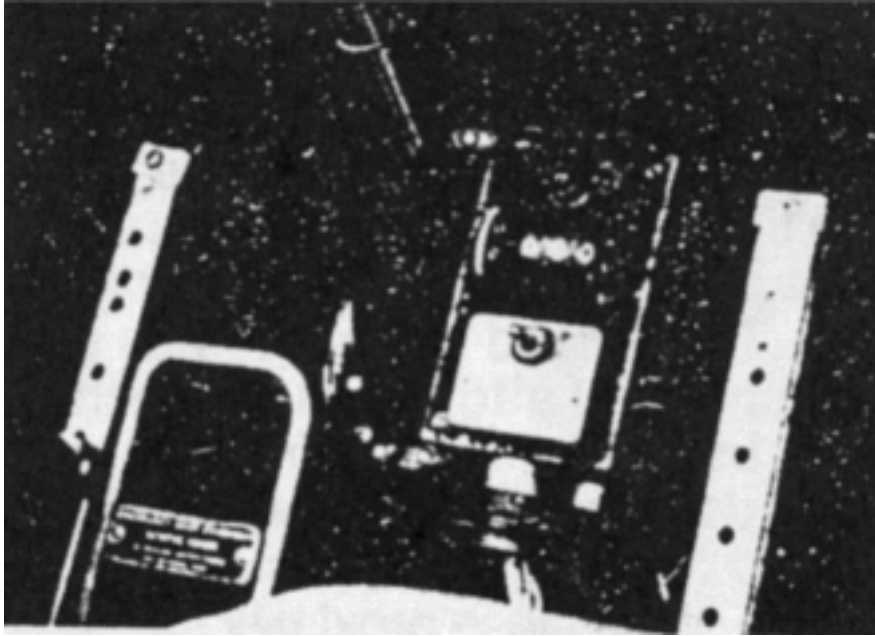
Relay box has indicator light and counter to measure extended antenna.

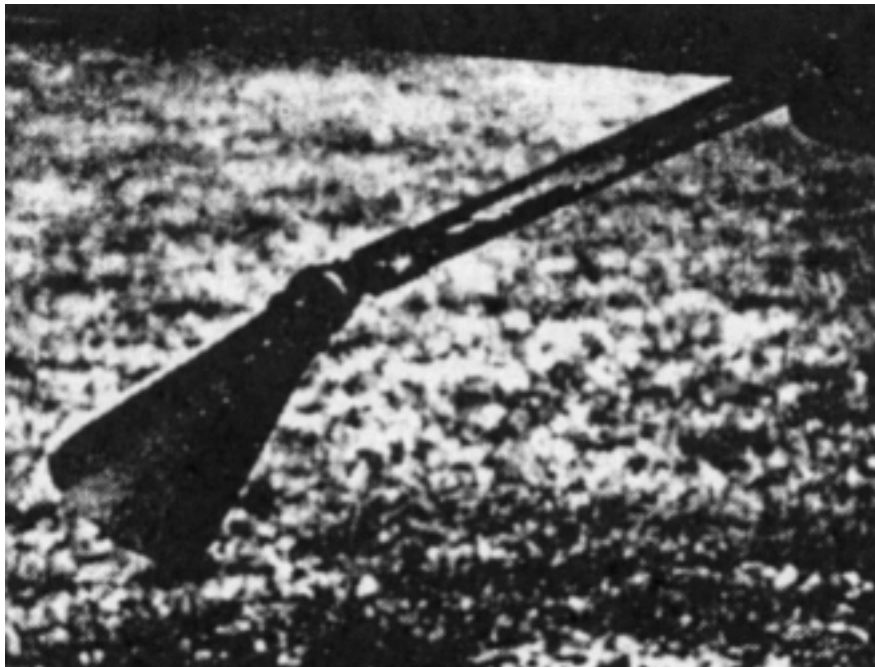
Top portion of bottle makes excellent stretcher for trailing antenna.
