Tips from Comanche *Flyer* magazines Feb 1973 – Sep 2012

## CHAPTER FIVE

### MAINTENANCE

### (GENERAL PROCEDURES, PAINTING, PLANNING, CORROSION CONTROL, HANDLING)

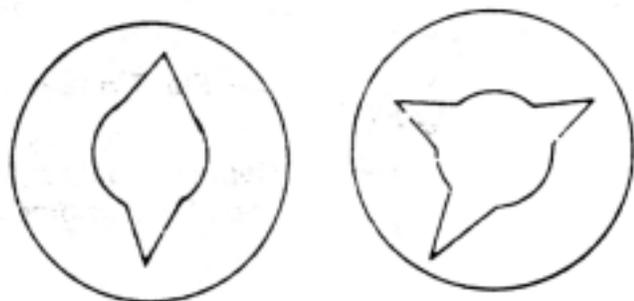
The local Piper dealer, an FAA approved repair station, didn't give us any satisfaction, so we called in a neighbor A & P of the grey haired variety who recommended that we check the torque values on the Lord mount bolts. We had already done that, so this time we removed the rubber donuts for an internal check as per the service letter. They looked something like this: Externally, it was impossible to tell how badly they had deteriorated. At the same time, we removed the stabilator, weighed the bob weights, re-balanced it, and replaced it with new bushings.
