CHAPTER SEVEN

LANDING GEAR / BRAKES (WHEELS, TIRES, STRUTS, BRAKING MECHANISM)

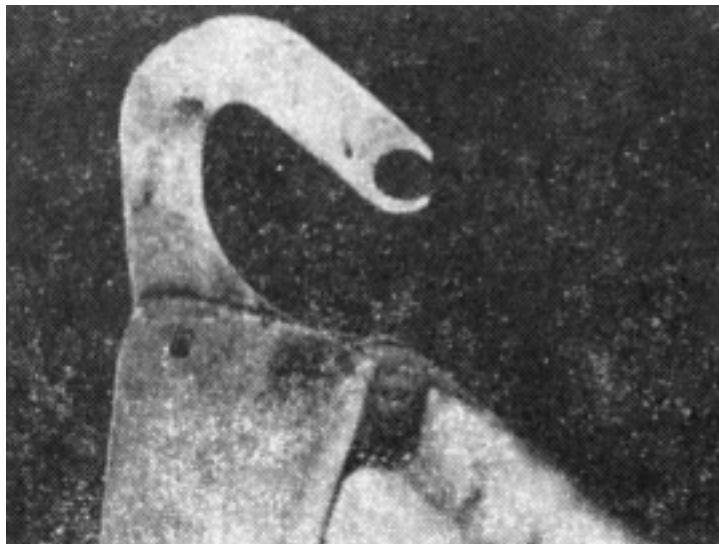
Check Those Gear Door Hinges

The picture to the right shows how the hinge had worn through over the years. If you haven't had your hinges checked recently during your annuals, (oh yes, we usually wiggle them around a bit) you might want to take a look. As you know, the hinges curve up into a cowl channel where it is impossible to see their condition. Piper still manufactures the hinges but with a steel bushing pressed into the hole.

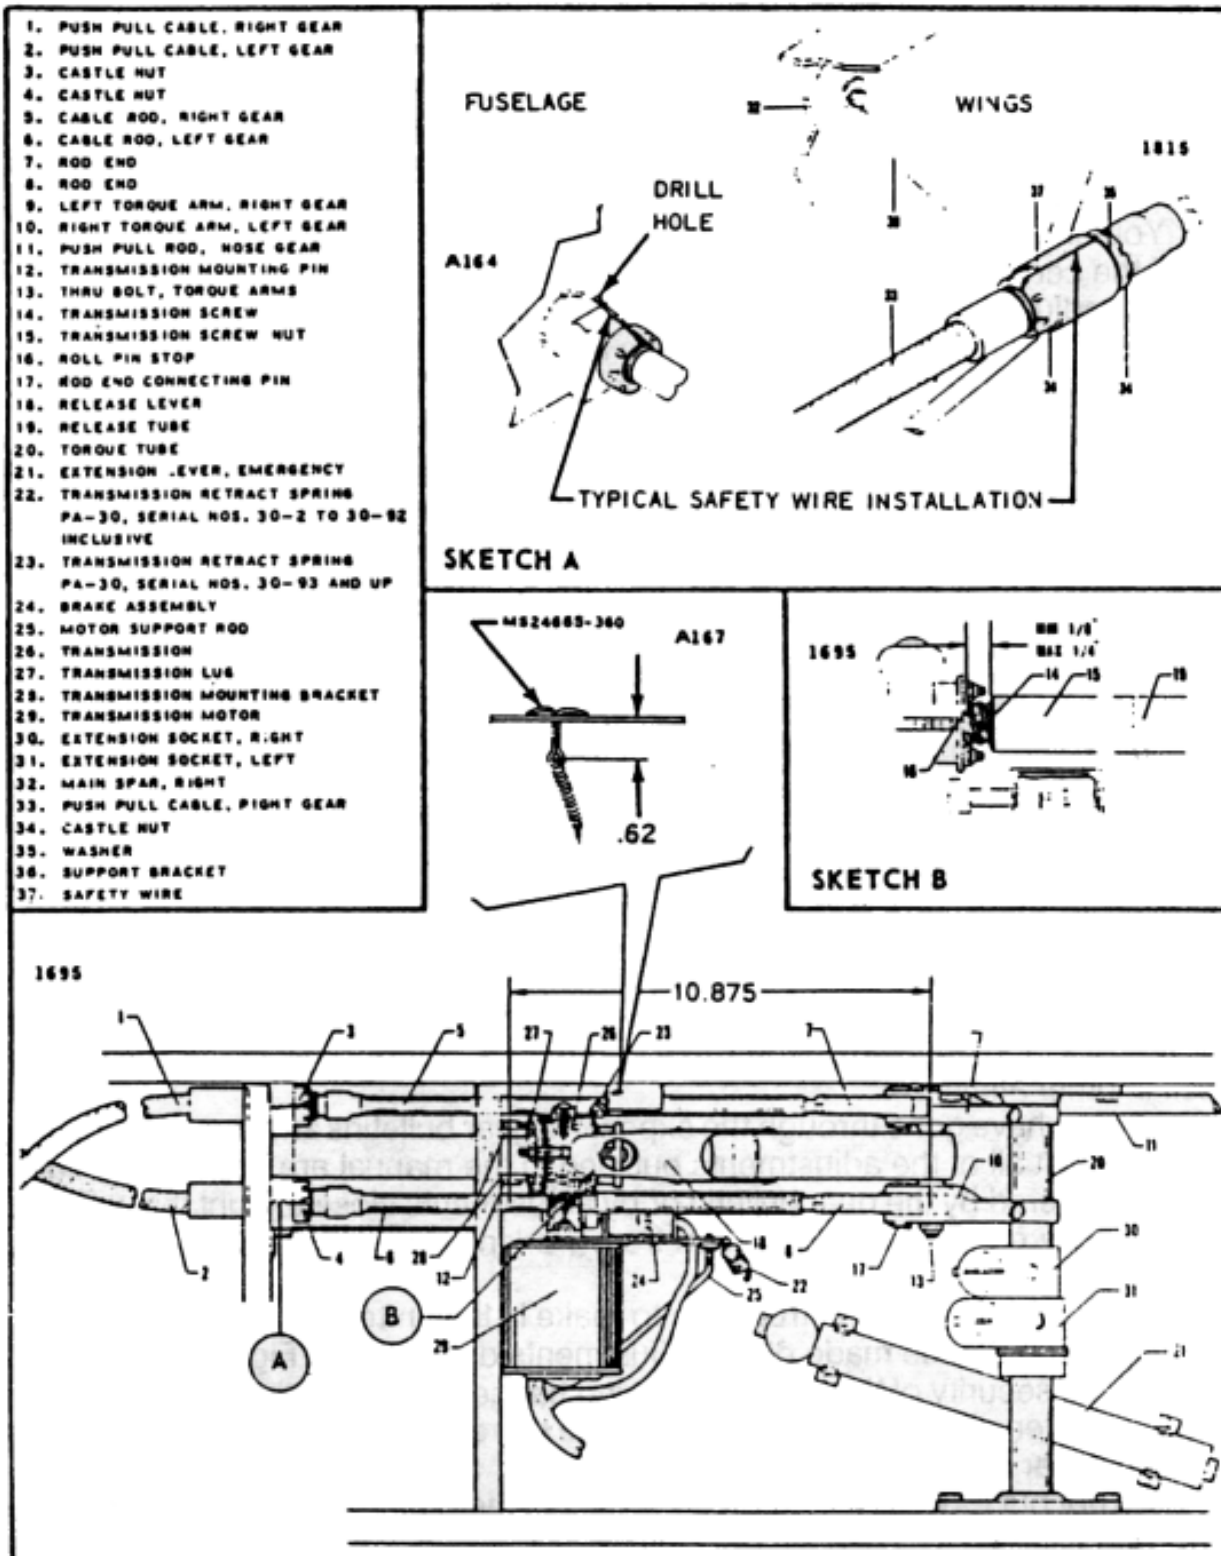
My clever use of this strategy had sheared two pivot (clevis) pins in the release lever, torn off the brake assembly and jammed the jammed actuator on through its jammed position and let the gear go down and locked. Not caring to further

Popping a breaker is small irritation, but it is no big deal as long as the emergency extension system works. The transmission, motor and actuating screw is spring loaded by the retracting spring (23). When the release lever is released, the retracting spring holds the whole mess up so it won't jam as mine did. This retract spring is held on the unmoving end by a cotter pin through the floorboard of the plane near the lower left corner of the opening. Piper noted on the drawing that the cotter pin should be adjusted as to allow the end of the retracting spring to be suspended .62 from the top of the floor board. I guess they meant for this to be interpreted to be 620 thousandths of an inch with no plus or minus tolerance – or that it simply was not critical since such close calibration of a cotter pin could be somewhat demanding for us ordinary people. On my airplane the cotter pin had been pulled through the floorboard and had more than one inch below the floor. This slack allowed the end of the retracting spring to unhook and fall off. For lack of support of this spring the release lever jammed under the torque tube.

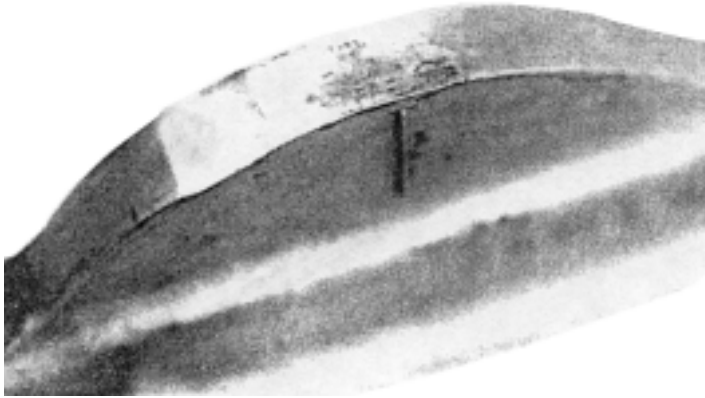
It is evident that as wear of the bushings progressed, the excess clearances were enough to allow peening or hammering of the cam faces due to increased play in the nose steering. A couple of my otherwise inexplicable swerves on the runway are readily excused on the basis of this wear. Less explicable is the ongoing lack of inspection and maintenance during the 23 year life span of the all consuming "period piece" that I bought to fly (and maintain!) as a hobby. Thanks to years of oversight and neglect, I had to remove the abused pieces and suffer an inordinate assault on my cash flow for the machinists spent five hours setting up the bellcrank (and five minutes to do the actual cutting) because of the need for the bushing rollers to follow both cam profiles, simultaneously, without binding. Also, I spent a couple hours on a lathe cutting out new oversize bushings from 4130 steel bar stock.

These parts, incidentally, are common to all PA-24, PA-30, and PA-39 airplanes. Curiously, the steering bellcrank was stamped Piper 21687, while the parts book calls out P/N 21768-00.

Considering the need for repeated removal and installation of the offending pieces, and the time consumed obtaining a field approval of the repair from the FAA, I felt this whole exercise could have been much less expensive, had a whole series of mechanics more carefully inspected the nose steering parts over the years. How much simpler it would have been had the bushings been routinely inspected and replaced – for the steering bellcrank itself would not have been damaged, necessitating expensive repair or replacement. (I would guess that more than half the Comanches and Twin Comanches still in service have suffered similar wear and neglect.)

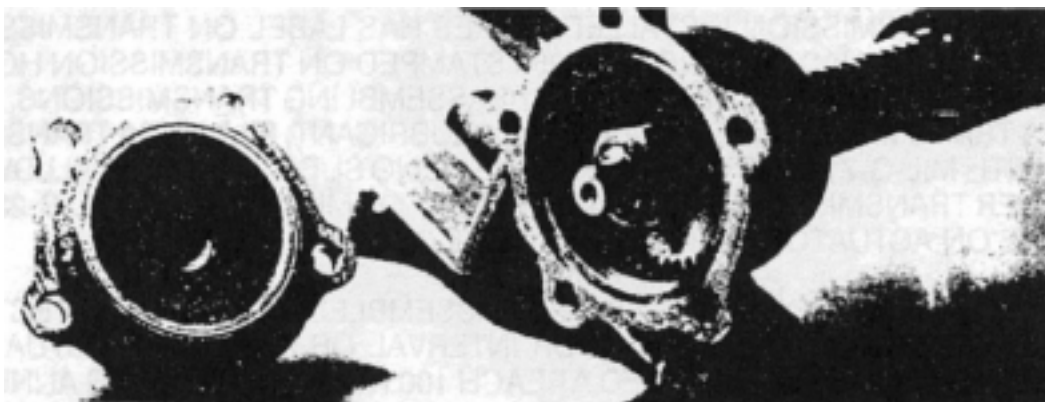
Upon taking out the Dura landing transmission and opening the transmission housing, I found just what I expected to see: grease that had hardened over many years to the point that it had to be picked out piece by piece. The gears had run dry for so long, the teeth, especially those of the driven gear, had worn so thin, they looked like knife blades. I recommended to Ken and Shirley that they should either replace that transmission or have it rebuilt soon, as it is only a matter of time before those teeth will strip. In the meantime, after cleaning the transmission thoroughly, I repacked it with MIL-G-21387 grease (Aeroshell No. 7 meets this spec.). According to the maintenance manual, this grease and grease meeting MIL-G-7118 are the only approved lubricants for the Dura transmission.

DURA transmission with cover removed and old grease washed away.

Only Dukes No. 4 grease is approved for the transmission manufactured by Dukes. Again, no substitutes are permitted.

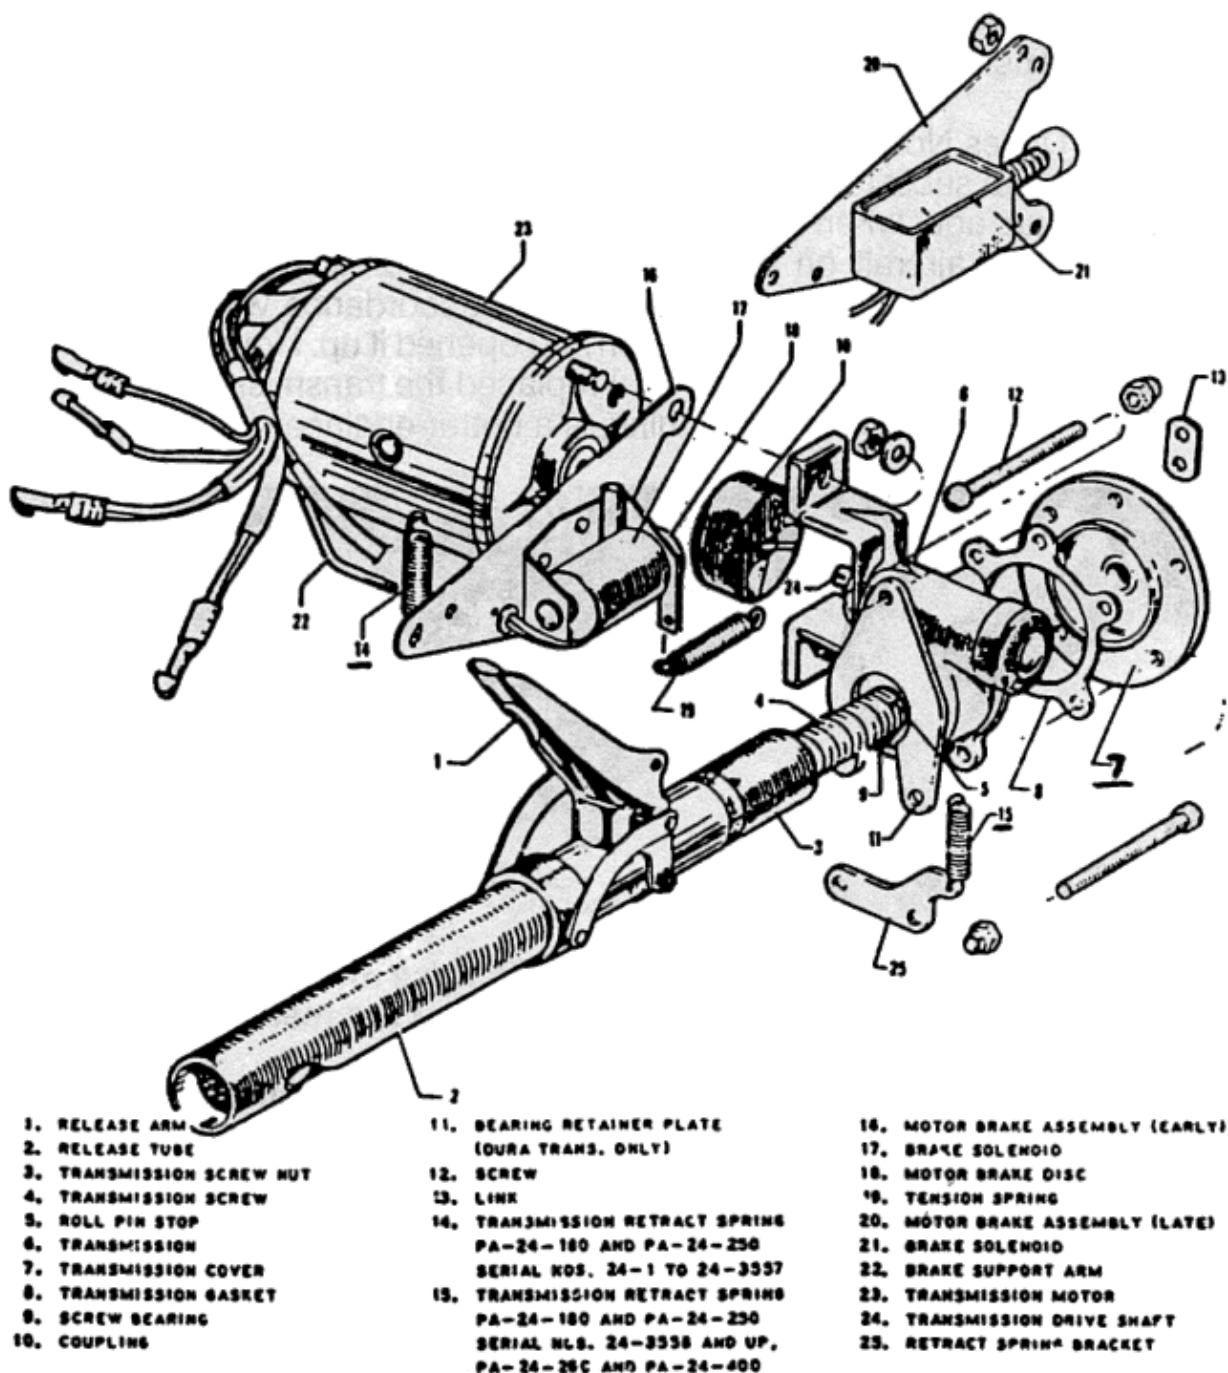
7. Transmissions should be disassembled, cleaned, inspected, and lubricated at each 500 hour interval or annually, actuator screws should be lubricated at each 100 hour interval or annually.

The transmission cover (7) has to be removed to clean and refill the transmission housing. – After reinstalling the transmission, make sure that the spring (14 or 15) is hooked up again!

These notes appear in the "Handling and Service" section of the maintenance manual. Since removal, disassembly etc. of the transmission should be performed by qualified maintenance personnel, make sure your mechanic, or shop, is aware of these notes.

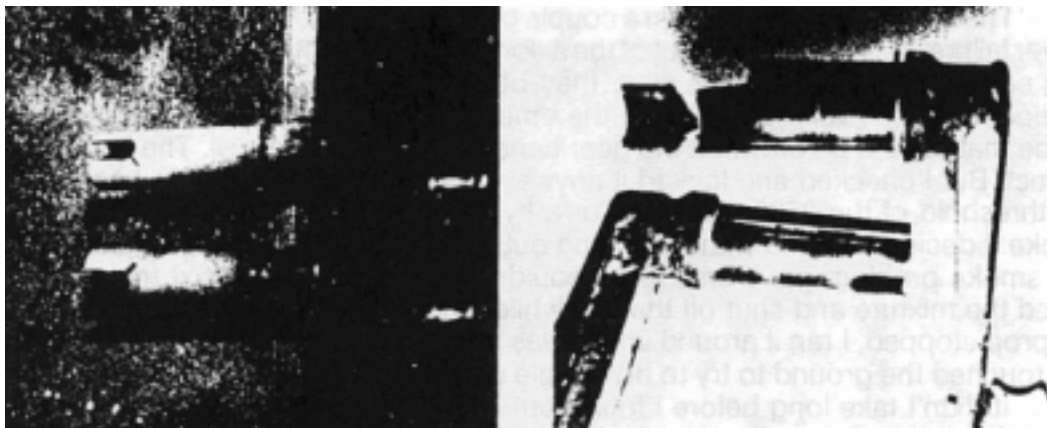
3. The right way – When viewed from behind (through the opening where the bungee is housed) and with the left gear in the full down position, the bungee arm should be approximately at a 4:30 to 5:00 position. On the right gear, the arm should be at approximately 7:00 to 7:30.

These arms can be obtained from Av-Pac by calling (800) 228- 1836. Bob Weber of Webco Aircraft Services also has these parts available. If you order a replacement arm, you will get #20846- 06 for the left and #20846-07 for the right. These will be the heavy walled ones that are on the 260's, the 400's and the twins.

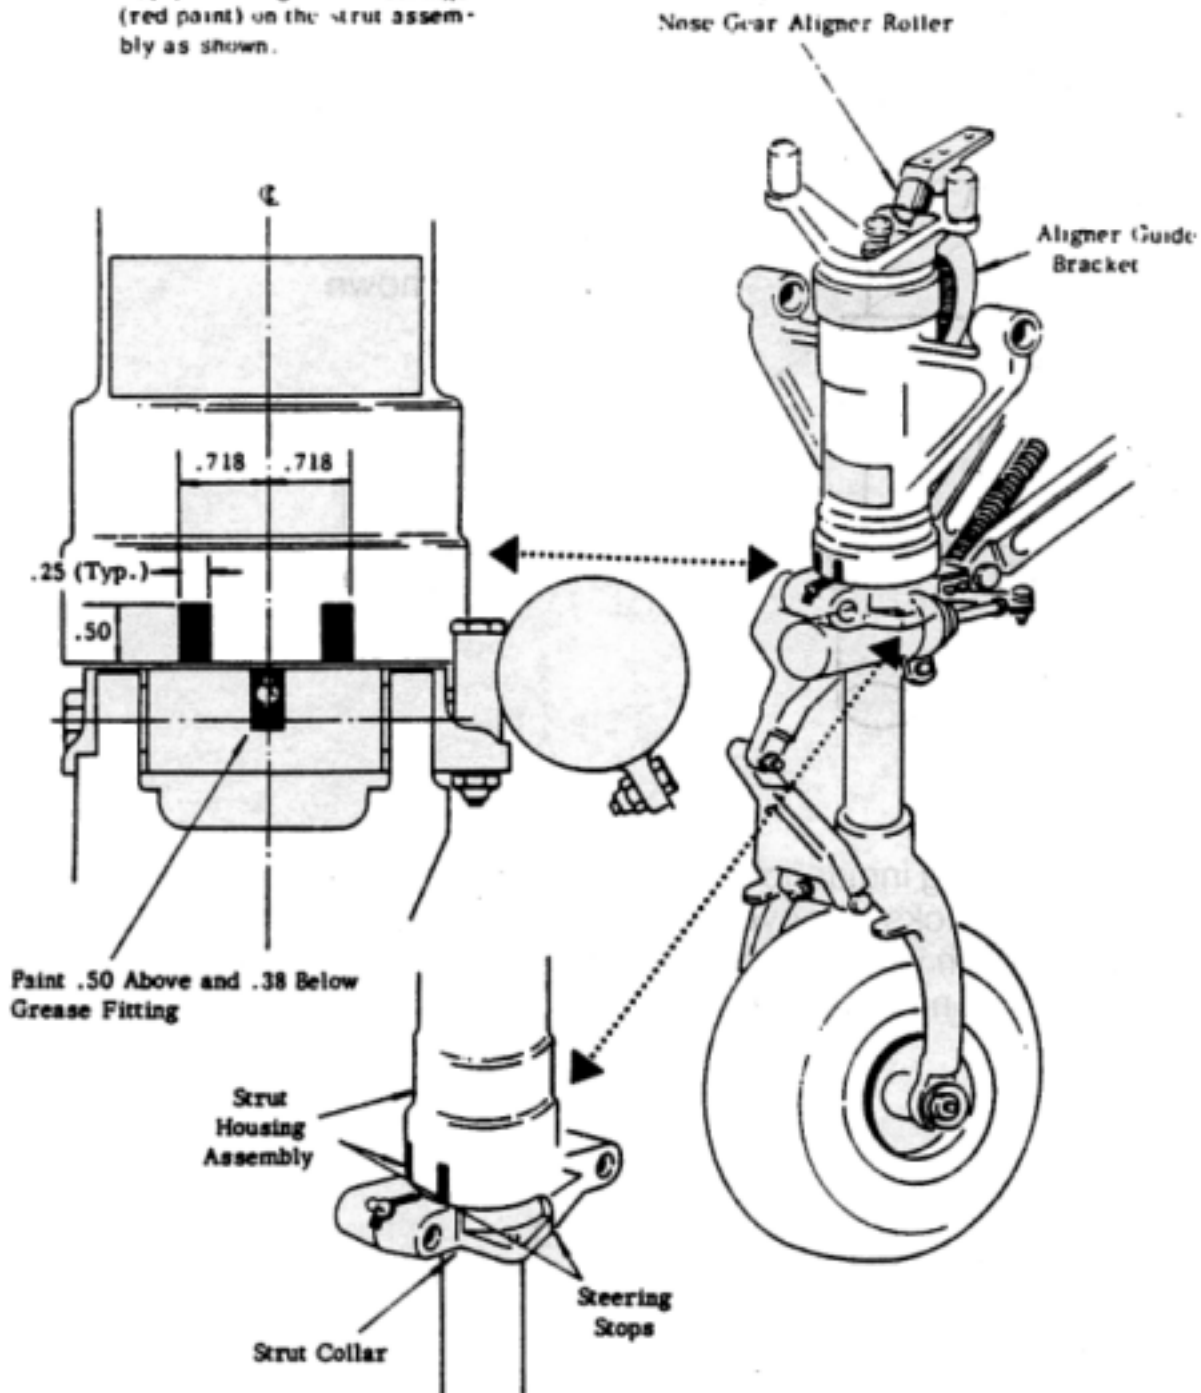
Service Letter No. 575

3. Perform a minimum of two (2) gear retraction cycles: one with rudder pedals completely depressed full left, and another with rudder pedals completely depressed full right. During gear cycling, observe that the aligner roller is engaged within the gear aligner guide bracket channel (reference attached sketch for a pictorial description).
 - a. If the aligner roller does not engage within the aligner guide bracket during gear cycling as specified above, it will be necessary to readjust the nose gear steering travel limits.
4. Apply steering limit markings on the nose gear strut housing as denoted on attached sketch.

Note: Apply steering limit markings (red paint) on the strut assembly as shown.

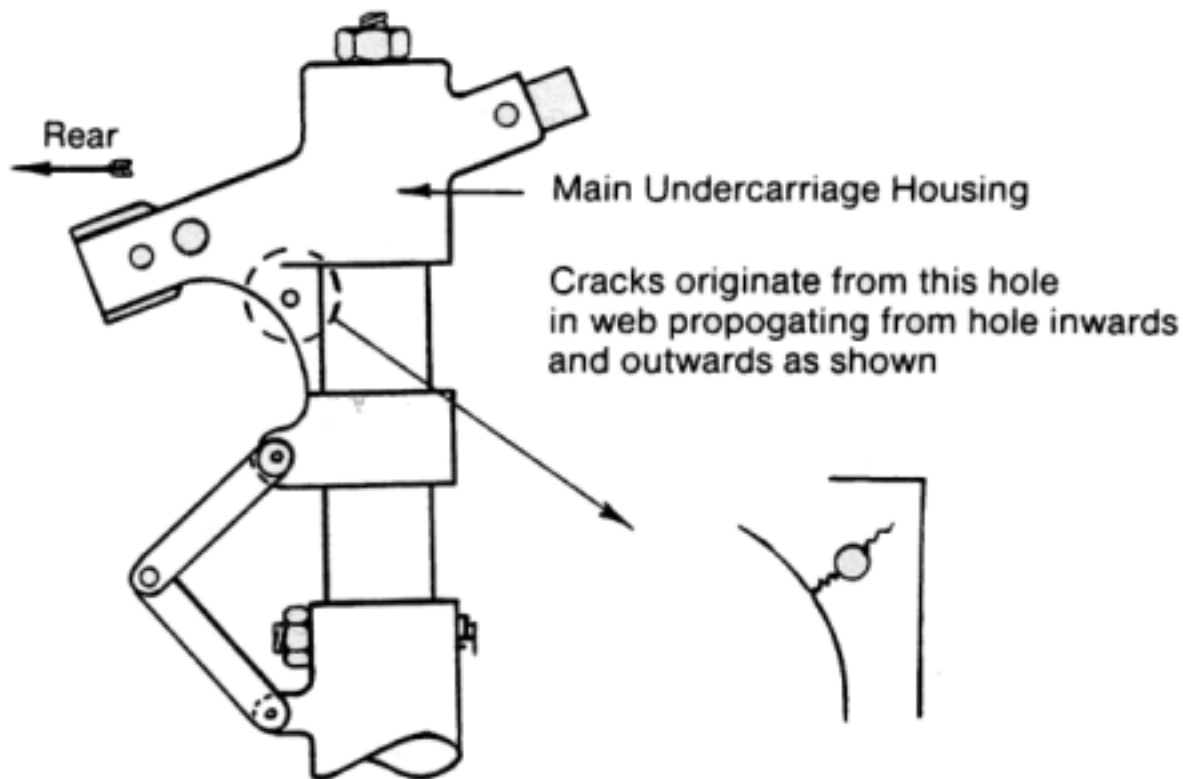
Gear; Cracked Housing

There are continuing incidences of cracks in Comanche main landing gear housings. To check for cracks, remove the bolt securing the clamp and slide clamp clear of web. Clean area in vicinity of hole and inspect for cracks visually with 10X magnifier or dye check. If no cracks are found, modify hole and web as indicated.

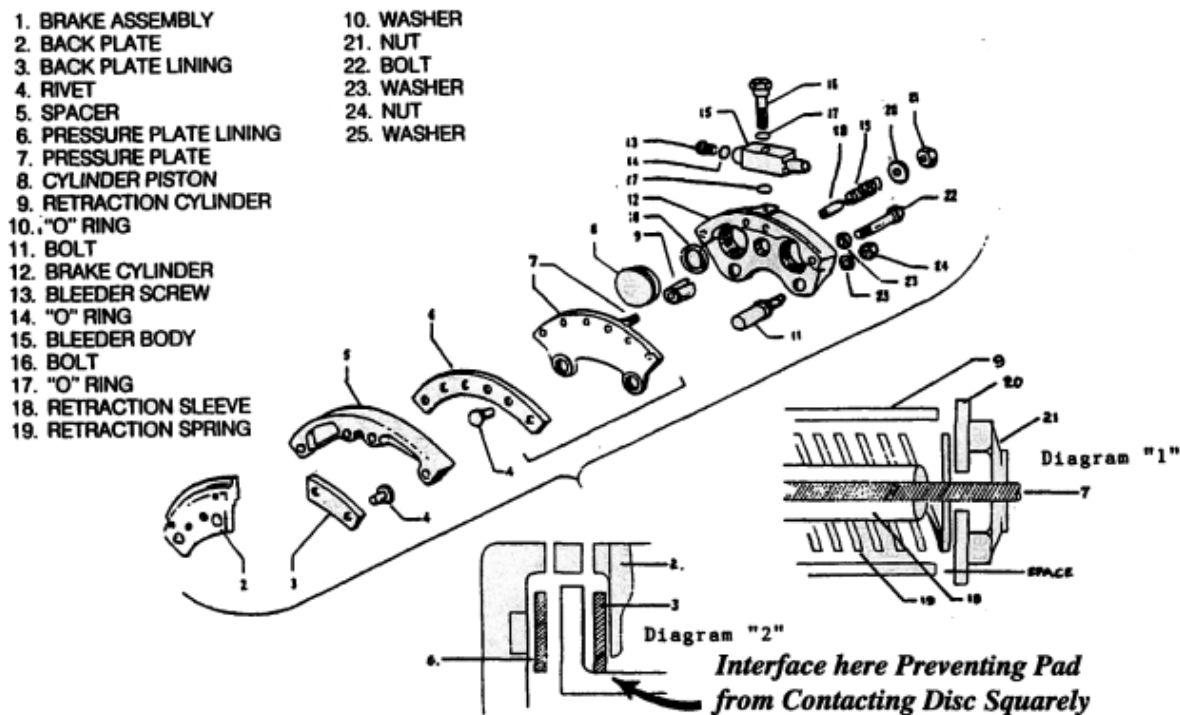
**FIGURE 6-28. BRAKE ASSEMBLY (CLEVELAND) PA24-180 and PA24-250
Serial Numbers 24 -1 to 24 - 3295**

When tightening the back plates down, make sure the tire can roll freely at all times. The back plates have pads mounted on them with three rivets each and are tightened down with 1/4" bolts that have 7/16" heads. If the brakes lock, look for this possible situation. See diagram "2".

Now that everything is tightened down, go inside the plane and push on the brake pedal several times. After the second or third push, the pedal should get noticeably harder. The cylinder pistons are moving out and the retract cylinder is being pulled into position. The tires should roll easily when the brakes are released - this is the reason for the space between the washer and the end of the retract cylinder. I hope this procedure will help some Comanche owners who have always had "sticky" brakes.

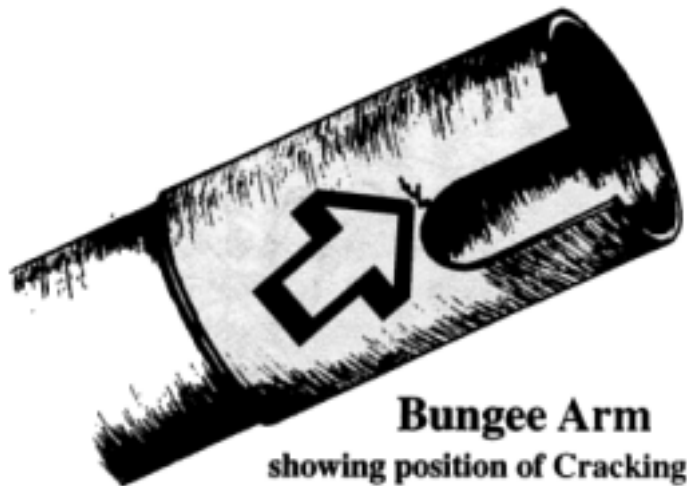
A mechanic had removed thin walled bungee arms and found them cracked and these were replaced with new thin walled arms. I assume the crack was at the point shown in the drawing below.

The thin walled arms were found only in the 180's and 250's. The thin walled is 0.062 and the heavy walled is 0.125 as found in the rest of the Comanche fleet. I am puzzled about the thin wall replacement as back in the mid '80's, if you ordered the proper part number from the parts book for a 180 / 250, you would automatically get a heavy walled bungee arm as Piper no longer made thin walled ones. If your 180 / 250 still has the thin walled arm, they should be checked every time you change the bungees. If the arm is in good shape, I see no harm in putting it back. If you find it cracked, it must be replaced. Replace it with the heavy walled unit as that is the only approved replacement part. We have talked about these arms in the past, but obviously the problem still exists.

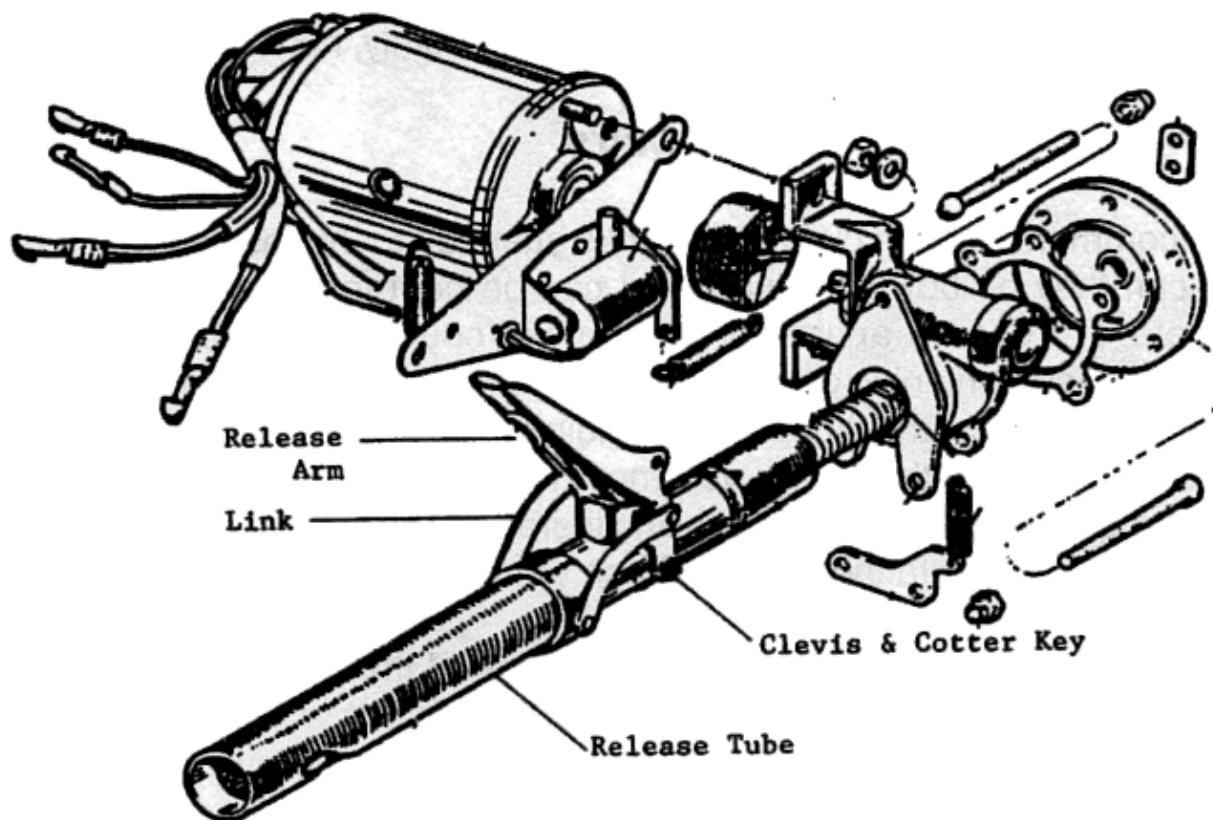
Although I realize that other things can go wrong with this mechanism, I have encountered two particular problems in my twin Comanche emergency gear release that I think ICS members should be aware of. I have found both situations: bent links and a missing cotter key / clevis pin on the emergency release arm.

1. The next time you get in your Comanche, pull up the emergency gear extension door in the floor and look at two things: the links attached to the red emergency gear release arm and the clevis pins which hold the release arm assembly on the drive shaft.

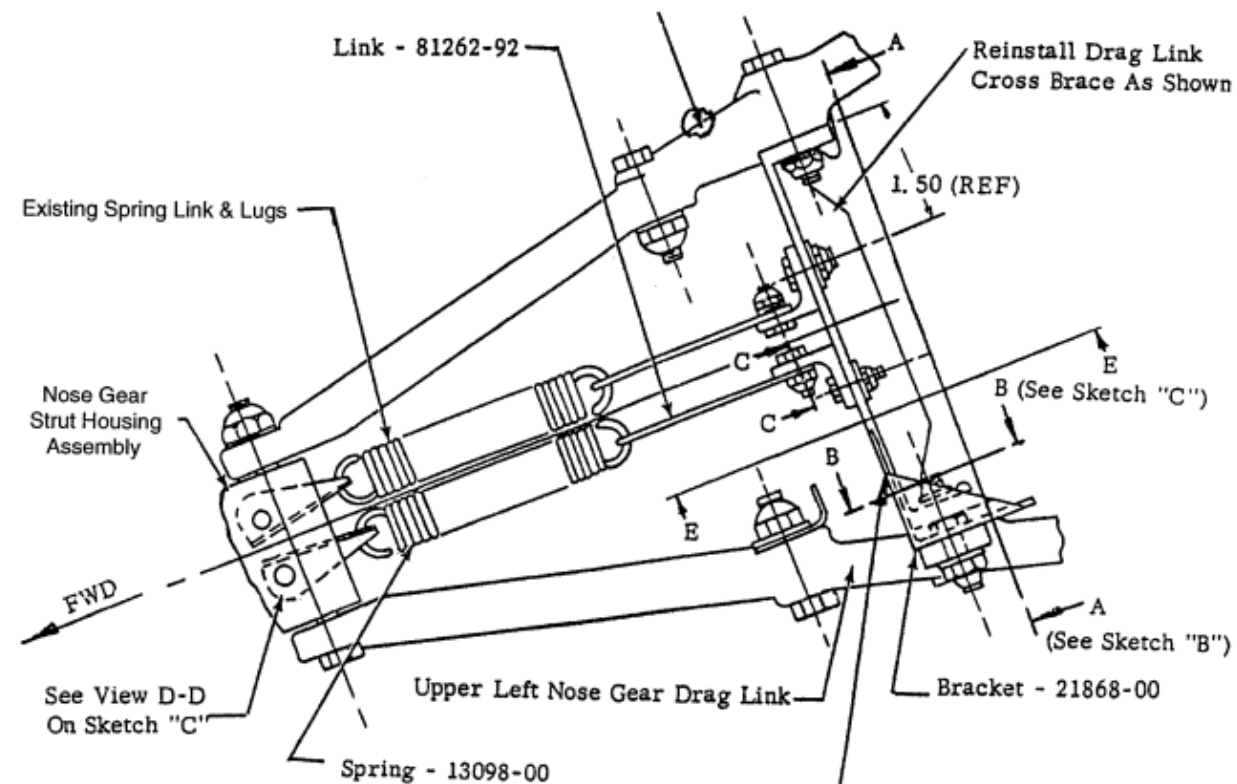
FIGURE 1
Spring Installation (View Looking Down)

I had a most interesting call from Wayne Damico ICS #12986. He just recently bought a 180 Comanche. After looking it over, he discovered that something about the nose gear didn't look right to him. The two springs on the nose gear weren't parallel to each other. My understanding is that a short time before he got the aircraft, the 1,000 hour gear inspection (Piper S/B 782B) had been C/W. The AP/IA had basically completely disassembled the gear and in putting it back together had installed the nose gear drag link cross brace backwards. Also the lugs that attach to it were on upside down. This action will make the springs (intended to hold the gear over center in the down position) do just the opposite; unlatch or pull the gear over center in the up position. Keep in mind that these springs have no effect on the gear when it's operating normally; they only come into play when the gear has been disconnected to use the emergency system.

For example, a number of years ago a member had this same inspection done then flew the airplane a year or more. Then on a trip to Mexico the gear didn't go down (at this point, I don't remember why). He put it down using the emergency method and after a short roll out the gear came up. Inspection showed that the springs were on the wrong way causing the gear to come up. If you have had the inspection done on your aircraft, look it over to be sure that everything is together properly. I want to thank Wayne for being so observant on the new aircraft. We are also showing one page from kit #761-082 so that you can see how it should look.

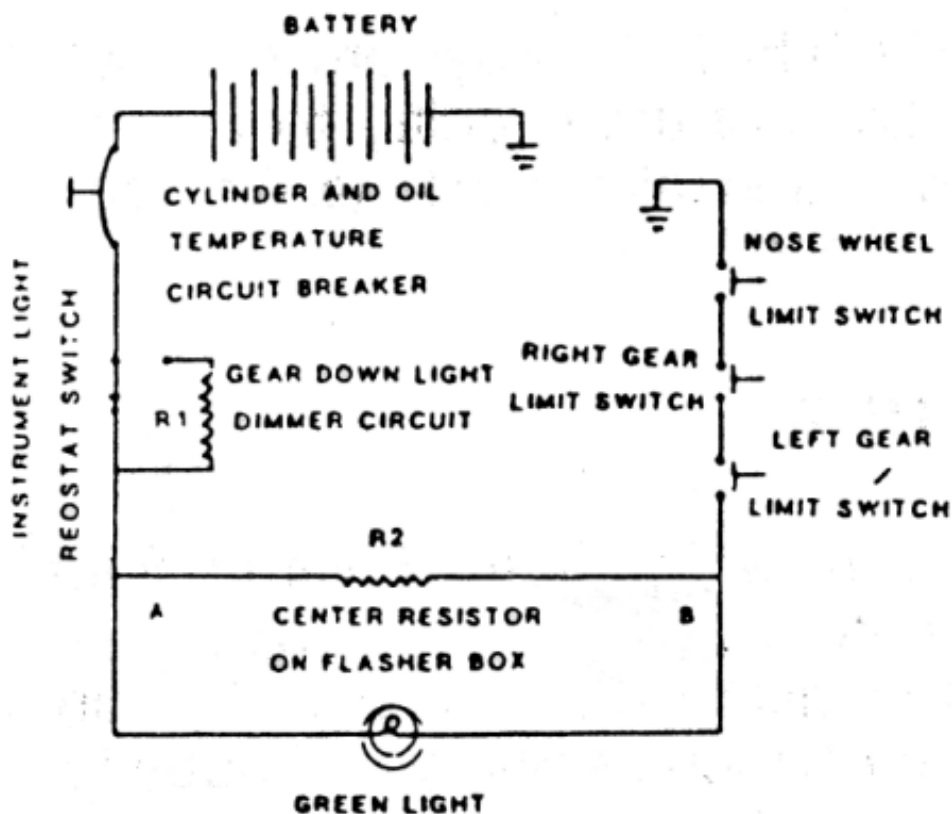
The circuit is fairly simple. Power for the green light comes from the cylinder head temperature and oil temperature circuit breaker. This enables the green light to function with the gear motor circuit breaker popped. The next item in the chain is the green light dimmer portion of the instrument light rheostat and switch. With the instrument light switch on, the resistor (R1) is in series with the green light, then the green light is dimmed for night operation. R2 is a resistor that is in parallel with the green light. The resistor provides current flow through the circuit when the light bulb is burnt out. The resistor (R2) is located in the center of the flasher box under the nose cowl (PA-30/39) on the member where the voltage regulators are attached. R2 is the center resistor. The green light socket is insulated from the instrument panel with insulating washers. If these break down, the light will burn any time the master switch is on. A chain of gear limit switches provides the ground for the green light.

From the diagram, one can see if a wire were to be used to jump from A to B briefly, the light should go out and the circuit breaker will pop. If we jumped from A to B briefly with a wire, the light would come back on if the system was spiked with the master switch or the instrument light switch. Using the jumper, we induced the problem encountered in flight.

If the above trick caused the malfunction; great. If not, don't despair. If only flight will induce the problem, put the aircraft on jacks, cycle the gear and make sure the gear is functioning properly. At this time, it is a good idea to open up the emergency gear access cover and put a mark below the push-pull cable ends in the full down position. This mark will enable one to determine if the motor and transmission has moved to full travel in flight. Alignment will not guarantee that the gear is locked, but malfunctions past this point in the system are fairly rare. While the aircraft is on jacks, check the gear limit switch adjustment and the general condition of the wiring. Careful attention should be paid to the butt splices, corrosion, fit, etc.

Next, cause the malfunction with the jumper wire or by flying the aircraft if you must. Run a jumper from the seat track to the light socket housing. If the light comes on, the problem is in the limit switches and associated wiring. If the light remains off, the problem is in the other half of the system or the socket itself. If it turns out that the limit switches and wiring are at fault, use wires to bypass the switches one at a time until the culprit is located. If the problem can only be simulated in flight, this will involve a few landings. We found the nose wheel limit switch to be our problem. There could be more than one problem. It appears that over the years the contacts corrode in the limit switches.

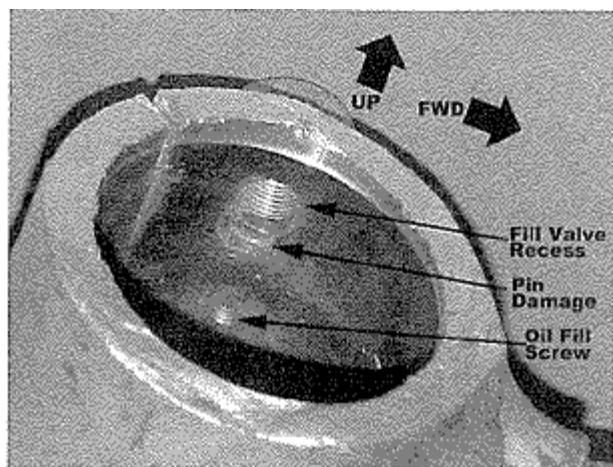
Fig. 1

Take a look at the gear strut exploded view in Figure 1 (I used a 260 single-fork diagram for clarity). What had happened was that one of the pins (#37) that secures the upper collar (#33) to the inner gear strut (#19) had aligned with the recess for the strut fill valve (#56-59) in the outer strut housing (#2). This allowed the pin to back out slightly into the recess and jam the strut!

Now for the rest of the story. It turns out that this event traces back to seven or eight years ago when I installed single-fork struts to reduce gear drag in the retracted position. It turns out that I happened to press one of the strut tubes into the fork in such a way that the upper collar pins were aligned with the strut fill valve hole and could potentially cause trouble if the strut were ever to be fully compressed.

Take another look at Figure 1. The Piper parts manual drawing makes it appear that there are four pins and holes for the upper collar, but ours had only two that were 180 degrees apart. If the strut is pressed into the fork with the upper pin holes aligned fore-aft, they will be 90 degrees away from the fill valve and there is no potential problem.

One replacement out strut assembly, two new pins (those suckers are \$50 each!), a new upper strut collar and three new o-ring seals later we were ready to fly.

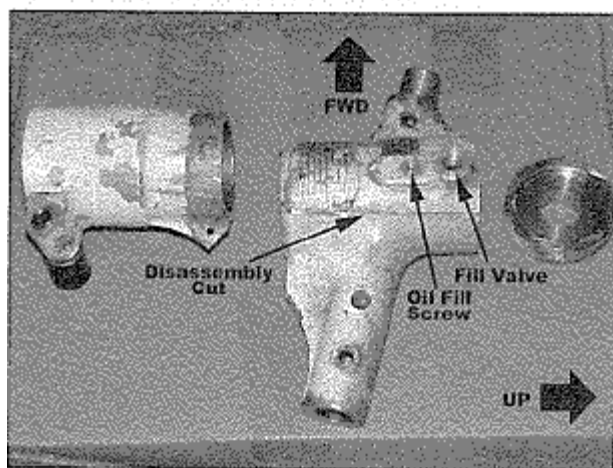
Fig. 2

Check out Figure 2 for a look at the interference and the damage. The bore should be smooth all around the valve recess. The valve recess is the larger circular opening at the upper end of the strut housing. Figure 3 shows that we had to cut the strut housing in three places to get it apart.

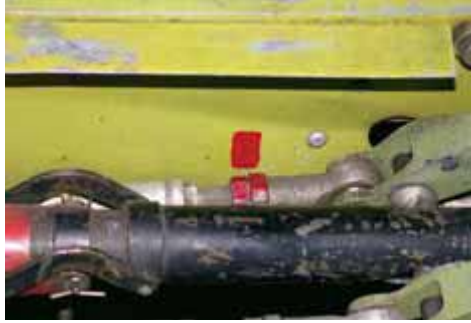
I know this airplane's gear was rigged correctly because I did it last year. The gear went down normally, and showed a green light. He wanted to be sure, so he pulled back on the telescopic extend bar and pushed it forward again to be sure it was locked. What happened next is most likely the reason why the gear folded on roll-out. The lever that you pull up to disconnect the gear transmission from the push-pull cables turned sideways. This action caused the push-pull mechanism to jam. It's unfortunate. See the photos.

Putting a red reference mark on the jackscrew tube gives you peace of mind that the gear is completely down.

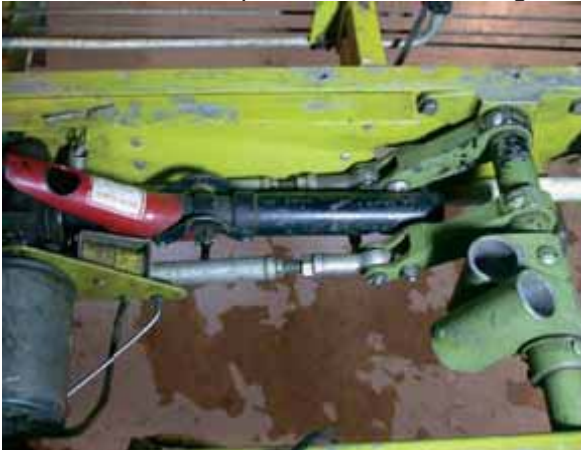
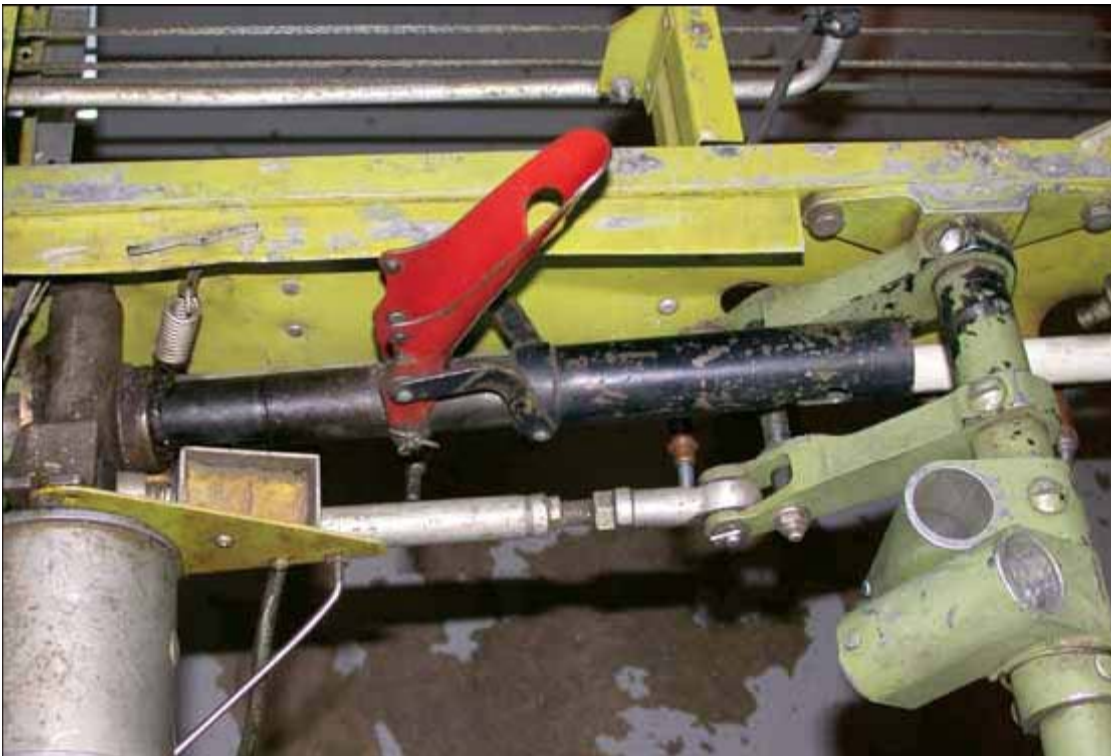
In these photos you can see that the lever used to disconnect the gear transmission from the push-pull cables.

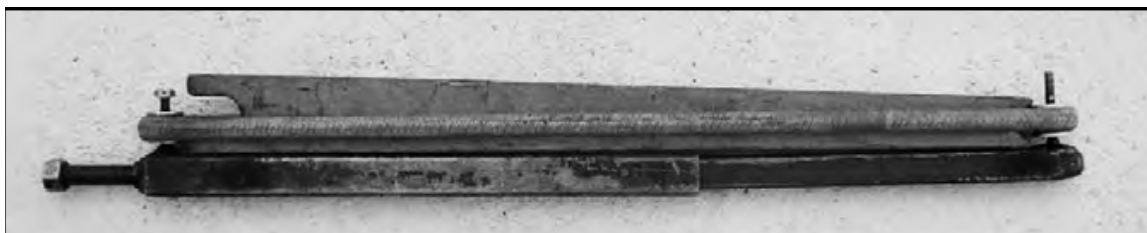
Now is the opportunity to check the bungee roller at the bungee arm, if it doesn't rotate, it's obviously seized. Feature Installation of Main Landing Gear Bungees by Matt Kurke, ICS #10288 This bungee bushing issue unfortunately is most common; it has swelled inside the roller from over-tightening the 1/4-inch bolt. The solution is to press the bushing out of the roller, ream the roller with an 8mm reamer (5/16-inch +0.003-inch), cut a 5/16-inch OD tube (1/4-inch ID) long enough to accommodate the roller plus two standard 5/16-inch washers. The bungee arm has a nut plate riveted to it. Lubricate the new bushing and roller contact area with a tiny amount of Lubriplate® Aero. Tighten the 1/4-inch bolt just to the point of contact with the bushing and check for free rotation. As you tighten the bolt, observe whether there is some prevailing torque; if not, the nut plate has lost its locking effect and will need to be replaced.

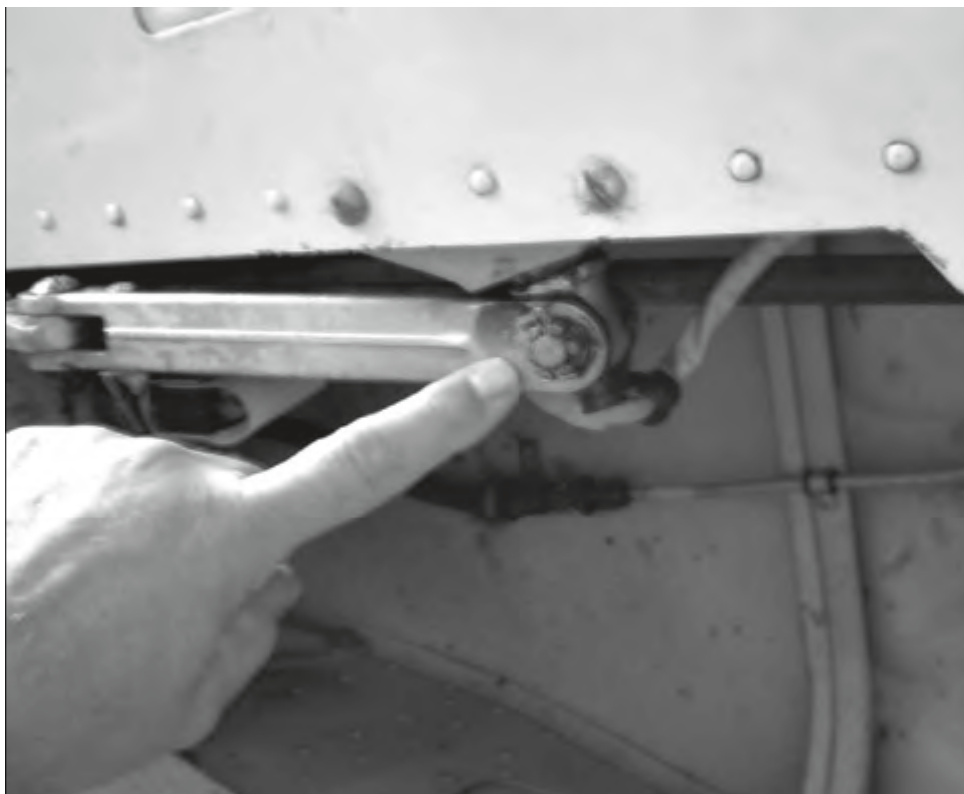
The clevis screw at the side brace stud
