# Main Gear Doors (Apr 2009)

## 6-39: Adjustment of Main Landing Gear Door

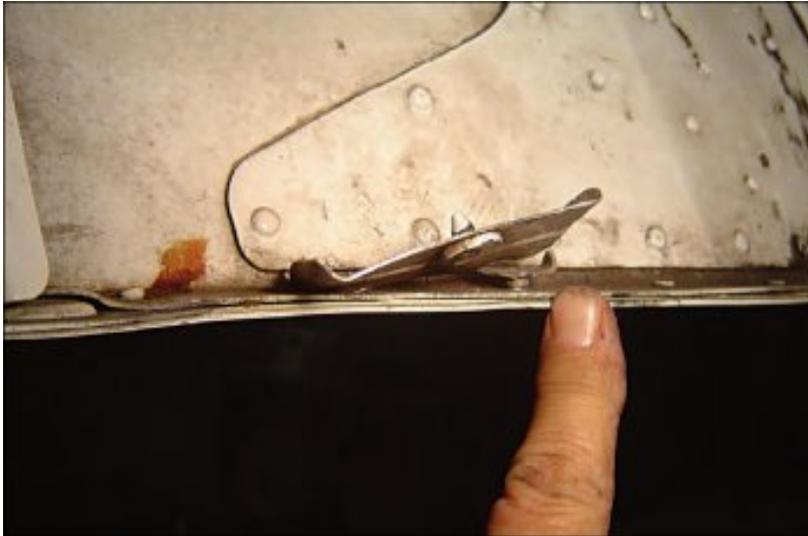
**Note c:** The 0.125-inch deflection means exactly that; you must have some deflection or the closure load on the door is excessive. Excessive, and you may have a bent bracket, and stress the gear door near the hinge causing a crack, which is why you typically see that ugly patch repair at that location, which appears in the first photo.
