CHAPTER EIGHT

AIRFRAME (CONTROL SURFACES, TRIM, SHEET METAL, FLAPS, GENERAL FUSELAGE)

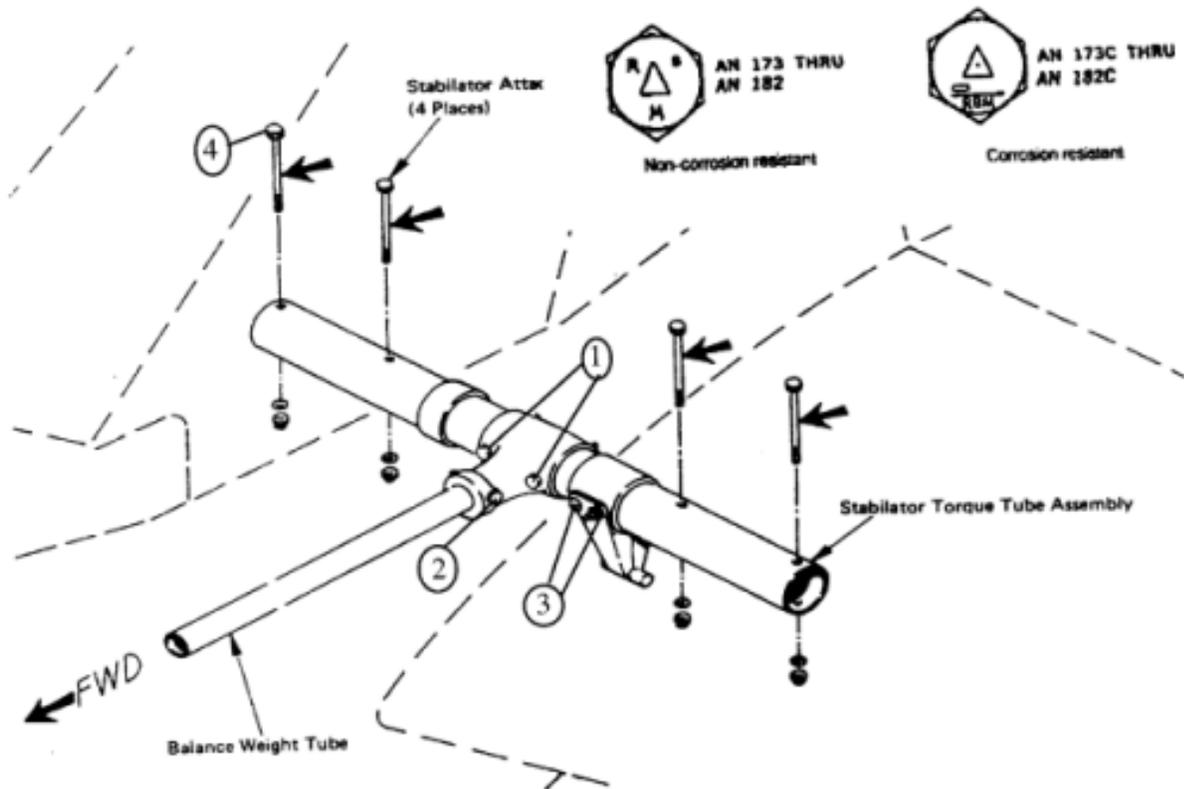
Remember that, unlike the rest of the aircraft, the stabilator tube itself is not corrosion proofed. The inner race of the bearings is such a close fit that there isn't room for it. There have been several cases where this tube has been found to be rusty. In some cases, the rust has been on the tube inside the stabilator making it very difficult to get the stabilator off. If yours has not been off the airplane in some years, I suggest it be removed and the tube checked at the next annual. Corrosion-proof the inside of the tube with zinc chromate or an equivalent product, and then coat the outside of the tube with a product like Lps #3, which will help protect it from rusting.

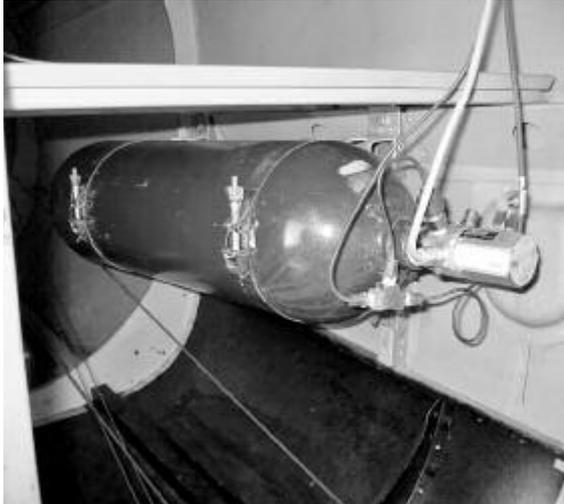
Figure 3

I placed a call to Scott Aviation's technical support to find out which regulator matched the characteristics of the original installation. These characteristics included input and output pressures/flow rates and the actuating geometry. The original 63.5 cubic-foot cylinder and regulator assembly, called out on the Piper Drawing 25432, is Scott P/N 800112-12. Scott compared the characteristics of this original installation (shown in Figure 3) to their new line of bottles/regulators and recommended a bottle/regulator assembly (P/N 895-09022) that included a 22-cubic-foot capacity composite cylinder and a regulator (P/N 803214). New cylinder brackets (P/N 800644-00) would also be required because the new bottle has a much smaller diameter than the original. The final step in the plan was to design an adapter that would transition from the bolt-hole spacing of for the larger diameter bottle brackets to the bolt-hole spacing of the smaller brackets. Figure 4 shows the new bottle brackets attached to the adapters.
