The Comanche Flasher (Dec 2011) Friedrich Rehkopf, ICS #9153

However, the repair or replacement of some small items, like the warning flasher unit, is not that well known.

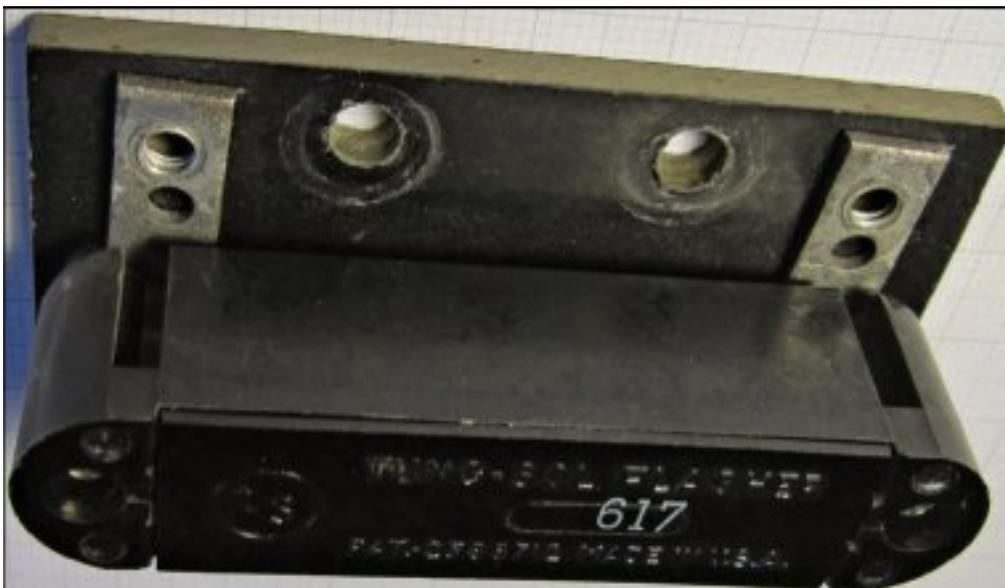
The flasher units (see Fig. 3) normally last a very long time. However, three types of malfunctions may arise. The most common problem seems to be a broken spot-welded joint between the very thin steel sheet metal strip that holds the flasher element in place, and the flasher element itself (Fig. 4). The second problem is that the contacts in the flasher element may become sticky and the force of the heater wire is insufficient to operate the contacts. The third failure is a burned heater wire.

Figure 3: The flasher unit.

The broken spot-welded joint can be repaired primarily by soldering the pieces together. I personally would not recommend doing this because of the disparity in size of the two parts which may result in a sub-optimal solder joint and a limited service life. Sticky contacts are usually easier to fix. Just spray some electronic contact cleaner or similar solvent onto the flasher element, and after a minute or two, blow it dry with compressed air. If you find a burned thermo-wire in your 617, you will need to replace it.

So what do you do when the flasher is not repairable? An easy solution should be available in solid-state electronic components. After searching the internet, I found a very small self contained flasher unit called the “m-Flash” which is intended for driving the LED replacement bulbs of motorcycle turn indicator lights. Normal flashers cannot be used for this function because of the very small current load of the LEDs. The flasher unit I found works with electrical loads as low as one watt, which is perfect for our application (Fig. 5). Thanks to miniaturization, this modern electronic component will fit into a very small space such as the original Tung-Sol flasher housing.
